# FRACTURE CRITICAL PIER CAP INSPECTION REPORT

SFN3103811 (HAM-50-2910)

US-50 OVER NORFOLK SOUTHERN,  
INDIANA AND OHIO RAILROAD, DUCK  
CREEK, AND RED BANK ROAD  
HAMILTON COUNTY, OH  
DISTRICT 8

March 2024

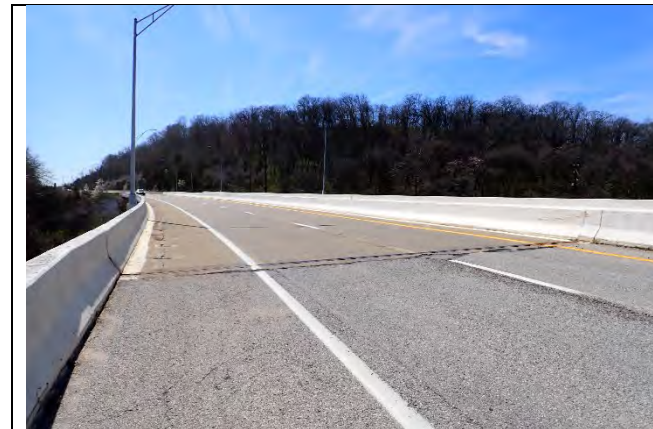
The eastbound right lane exhibited a pothole around an unsound patch 24 in. diameter by up to 2 in. deep, and the asphalt overlay exhibited raveling at the eastbound pothole. A few potholes and areas of failing asphalt patches were observed along header joints in the rear and forward slabs. Patches in the header joints in the eastbound lanes appeared sound. Overall, there were no major changes from the previous inspection.

Photograph 33: Eastbound end view, looking west.

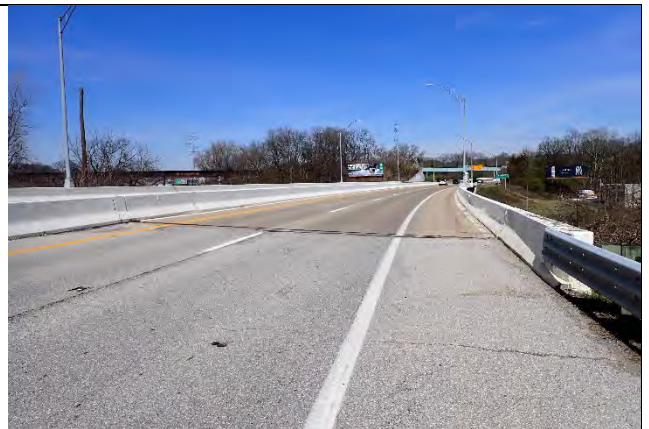
Photograph 34: Westbound end view, looking east.
