Structure Number: 0700312

Facility Carried: SR 7

Ohio Bridge Inspection Summary Report

BEL-00007-1187 (0700312)

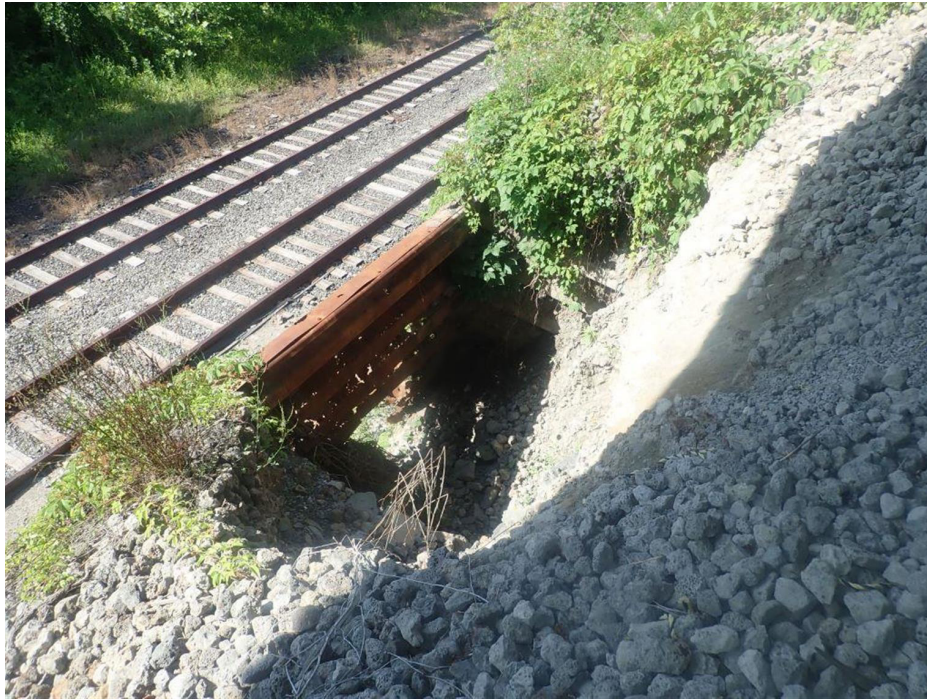
PHOTO 1

Advanced corrosion with up to 7' diameter corrosion holes in the rear right retaining wall has resulted in a large void (10' L x 6' W x 8' D) in the backfill with backfill material ~8' high beginning to encroach on the railroad tracks.

Description 10' L x 6' W x 8' D void in the backfill encroaching the tracks (looking southeast)

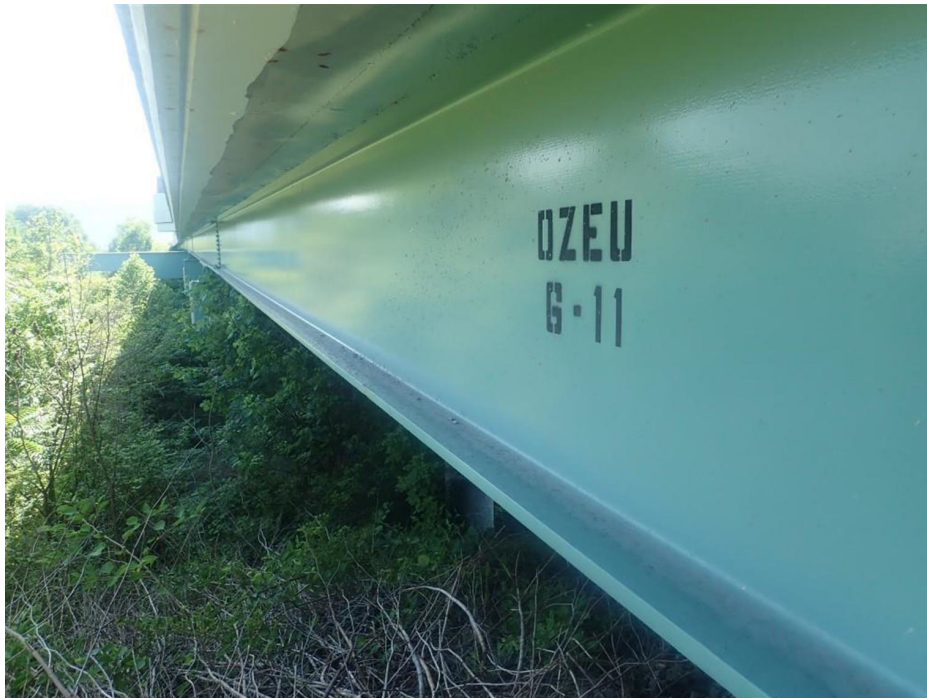
PHOTO 2

Description Paint ID on Beam 1, west face, near the Rear Abutment (looking northeast)

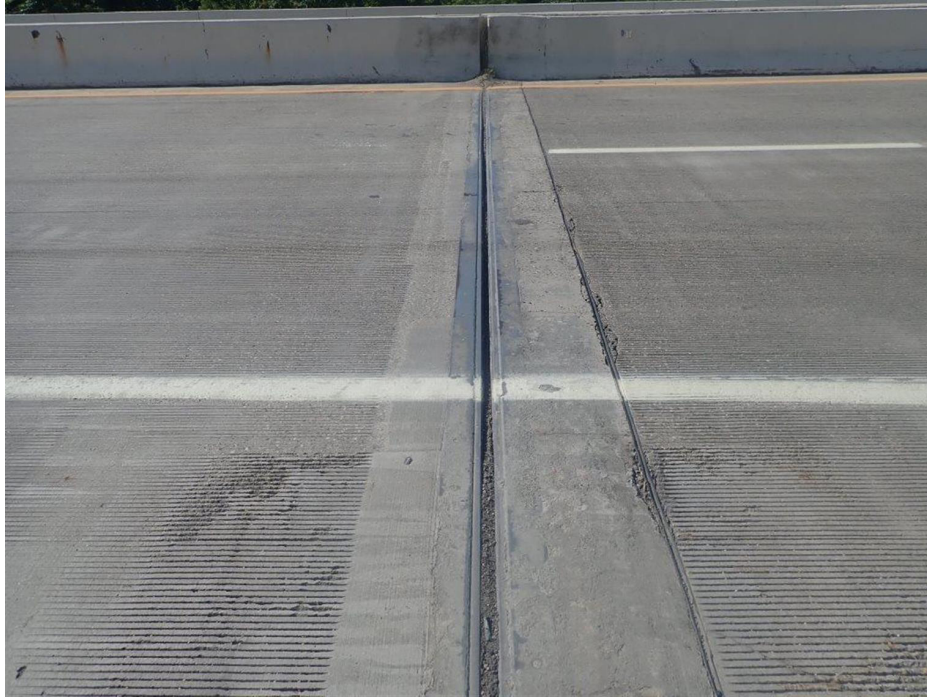
PHOTO 4

Description Rear Abutment joint, southbound lanes (looking east)

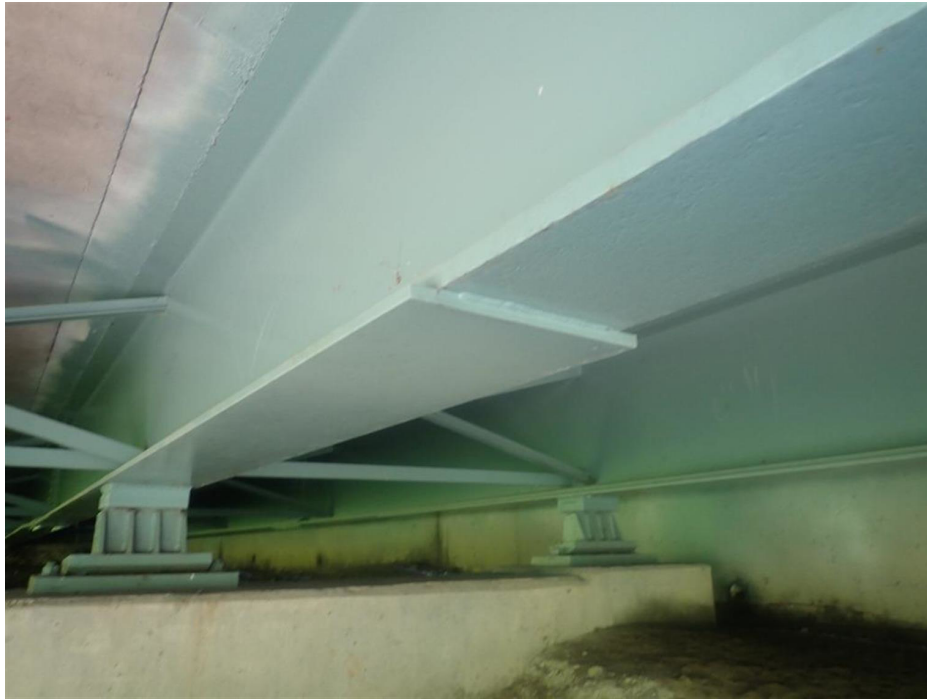
PHOTO 4

Description Fatigue Prone Detail (Category E') showing a welded cover plate over Pier 1 at Beam 7 (looking south)

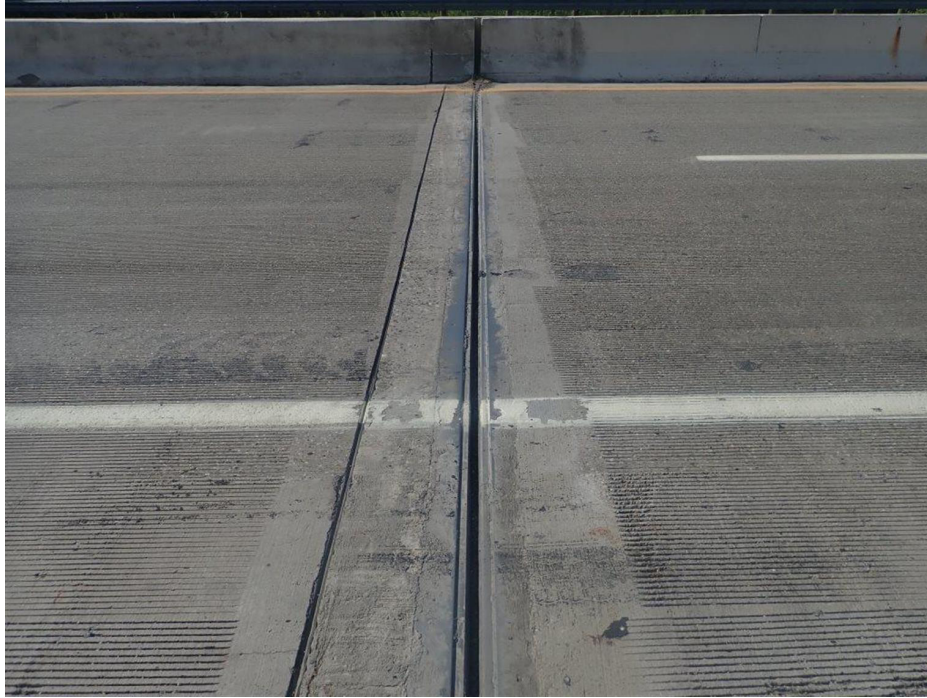
PHOTO 5

Description Forward Abutment joint, southbound lanes (looking east)

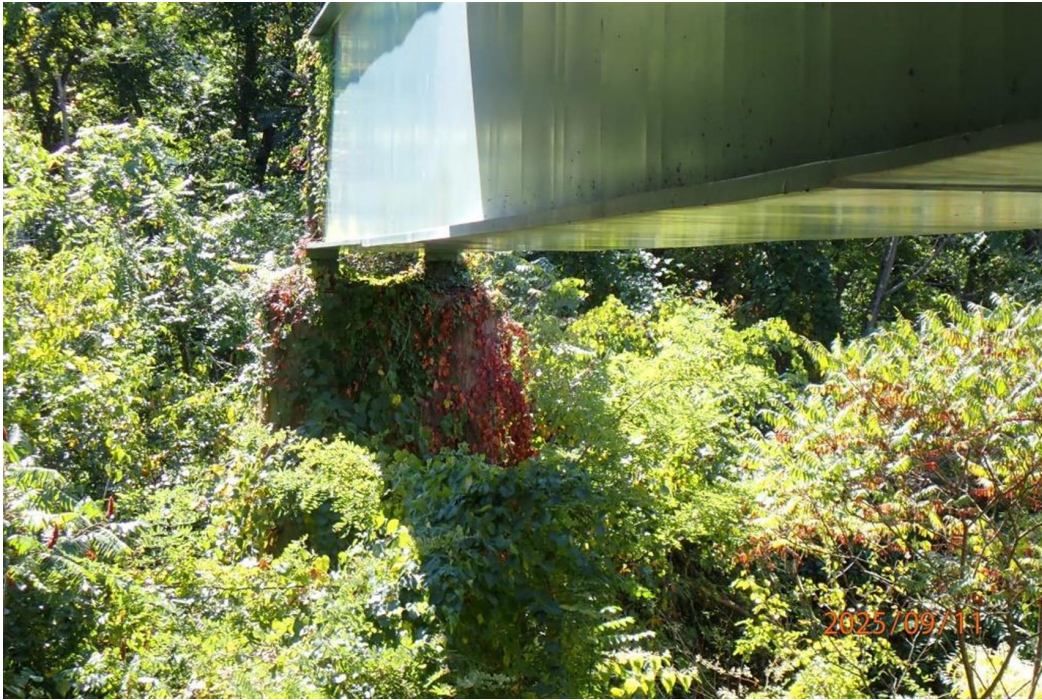
PHOTO 10

Description Vegetation encapsulating the east end of the Pier 3 bearings and column (looking east)

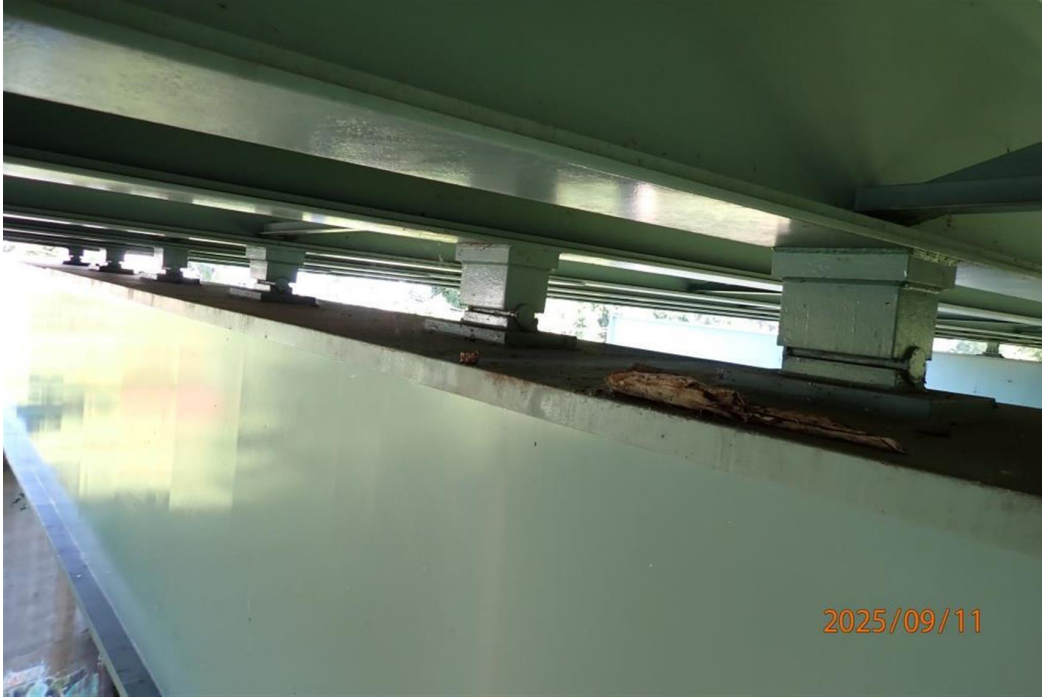
PHOTO 11

Description East rocker bearings at Pier 4 (looking southeast)

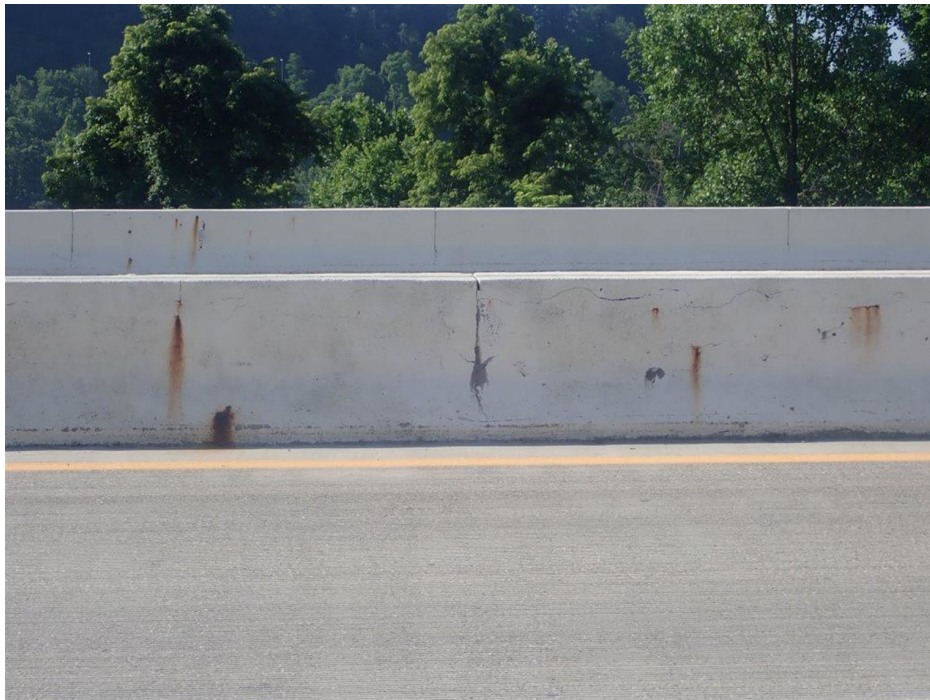
PHOTO 12

Description Bridge median at the forward end of Span 5, southbound lanes (looking east)

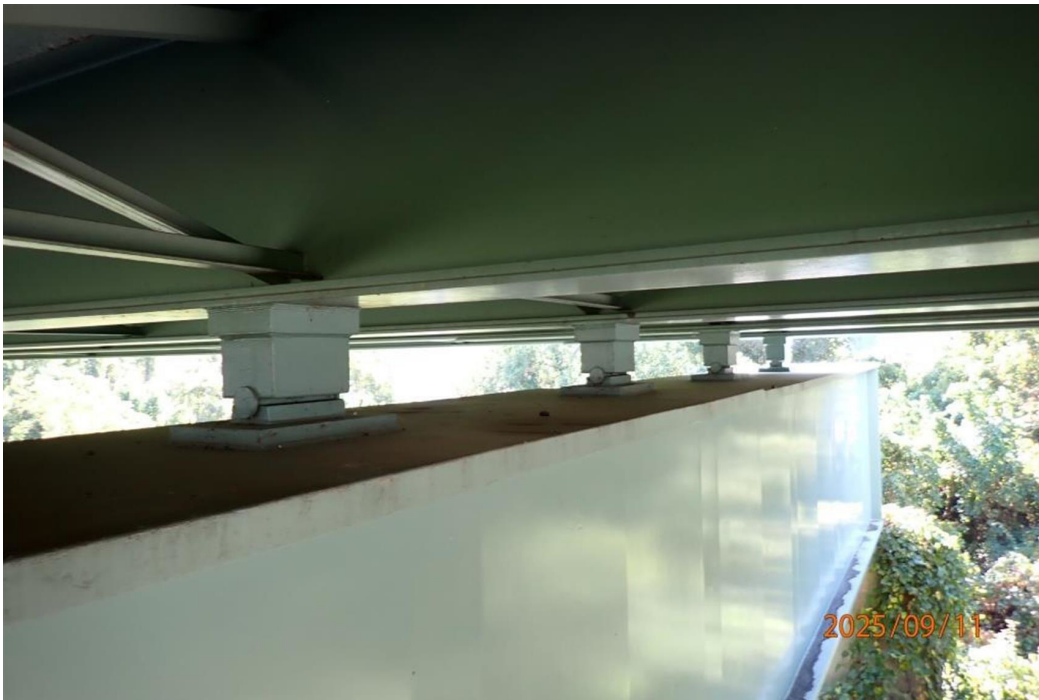
PHOTO 12

Description West rocker bearings at Pier 4 (looking southwest)

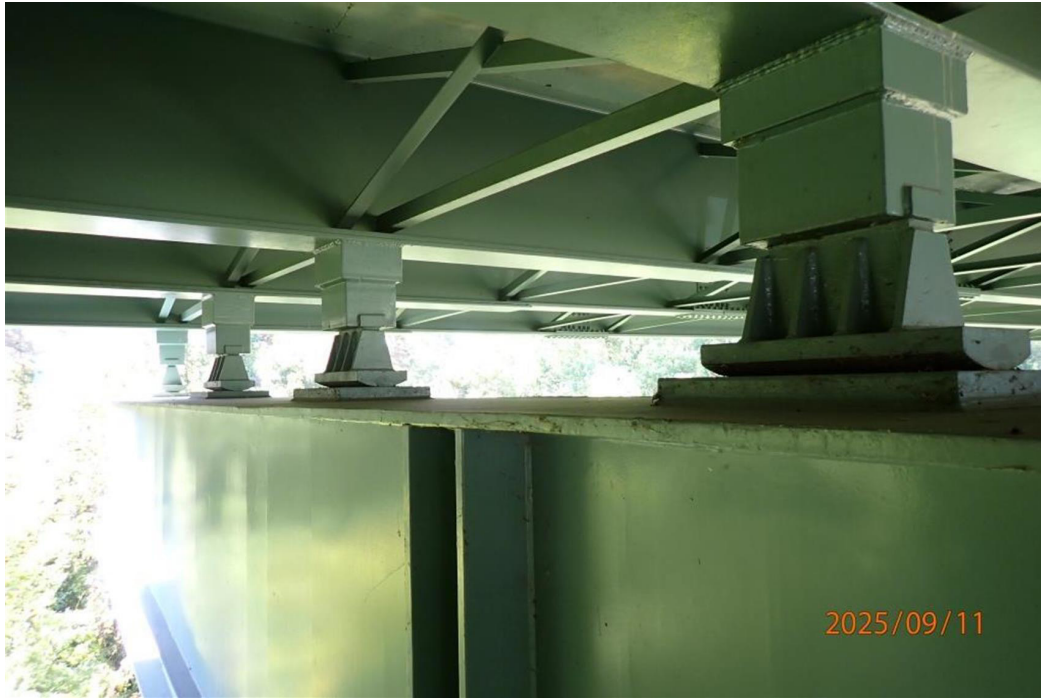
PHOTO 13

Description East rocker bearings at Pier 6 (looking southeast)

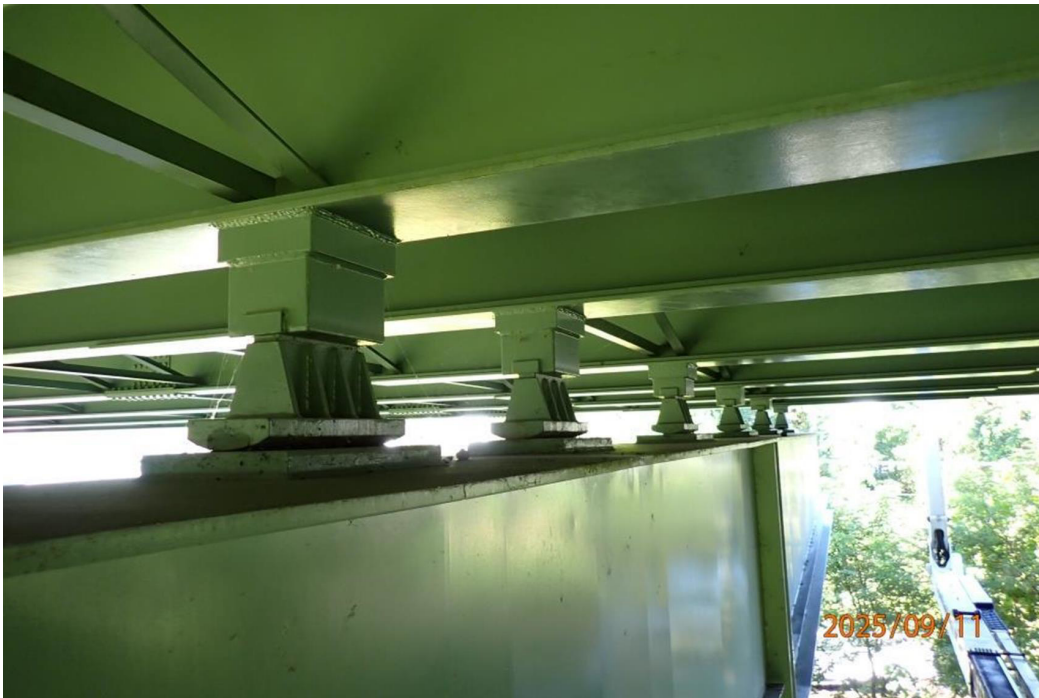
PHOTO 14

Description West rocker bearings at Pier 6 (looking southwest)

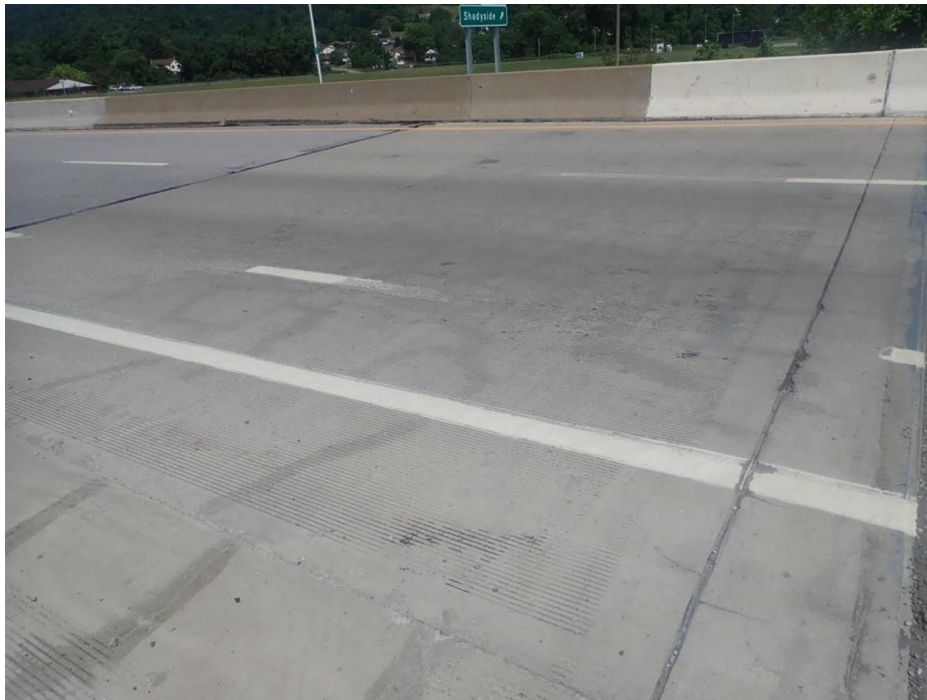
PHOTO 15 Condition

Description Rear approach slab, northbound lanes shown (looking southwest)

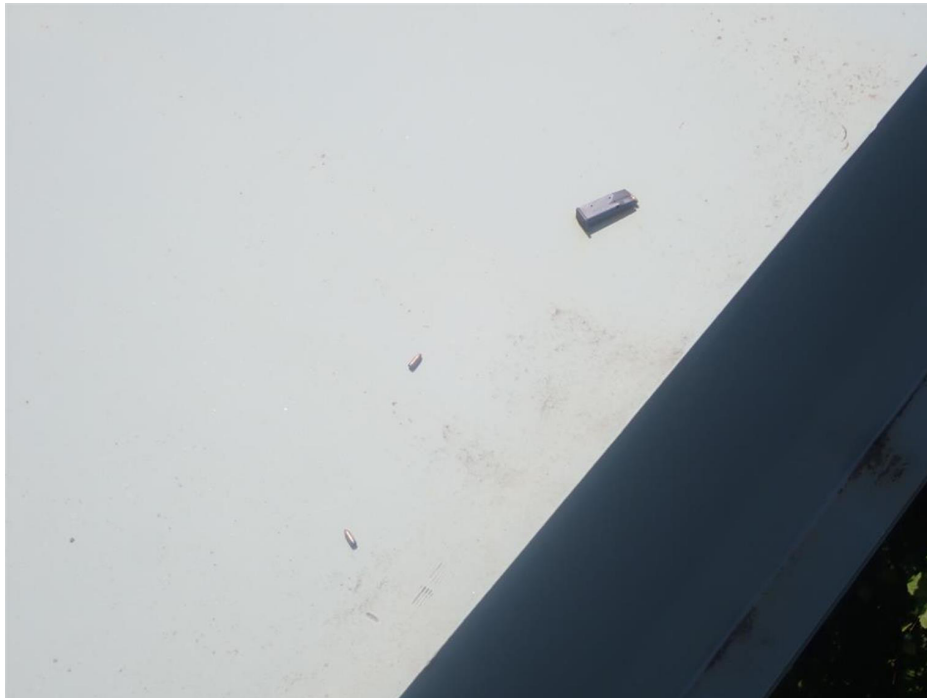
PHOTO 15

Description Bullets and magazine on the top of Pier 4, right end (looking east)

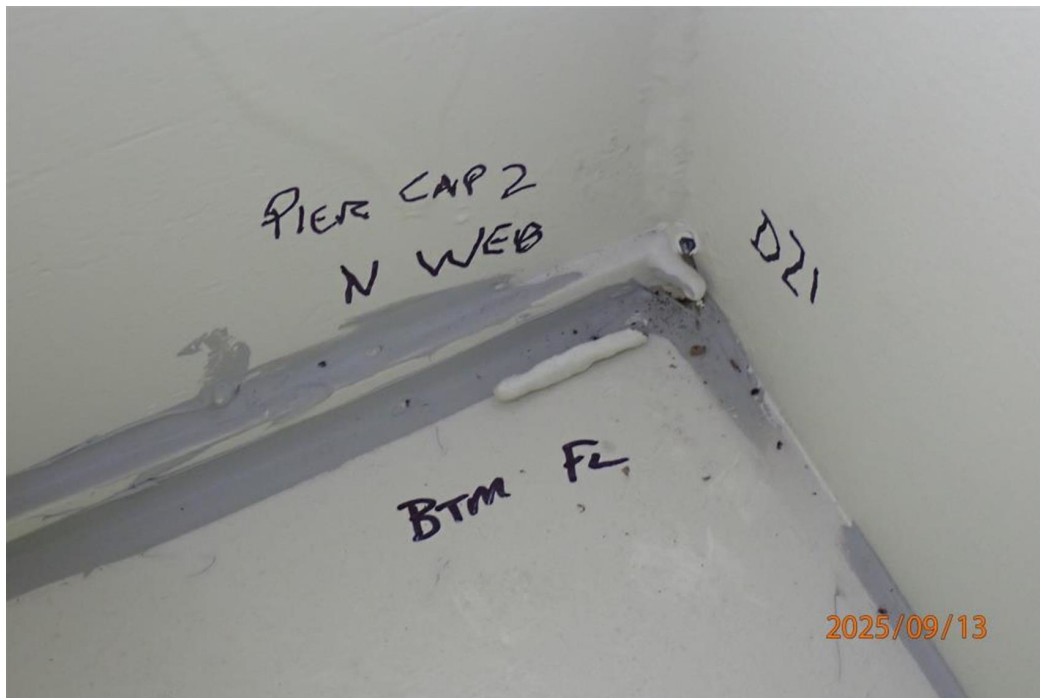
PHOTO 15

Inside & outside of the steel caps were painted (6/11) with doors added for inspection access. The interior of the steel pier caps were inspected during the painting process. Very clean on the inside with a few broken stiffener welds in each.

Description 2 errant weld extensions at the north web/bottom flange backing bar interface on the west face of Diaphragm 21 inside Pier 3 (looking north)

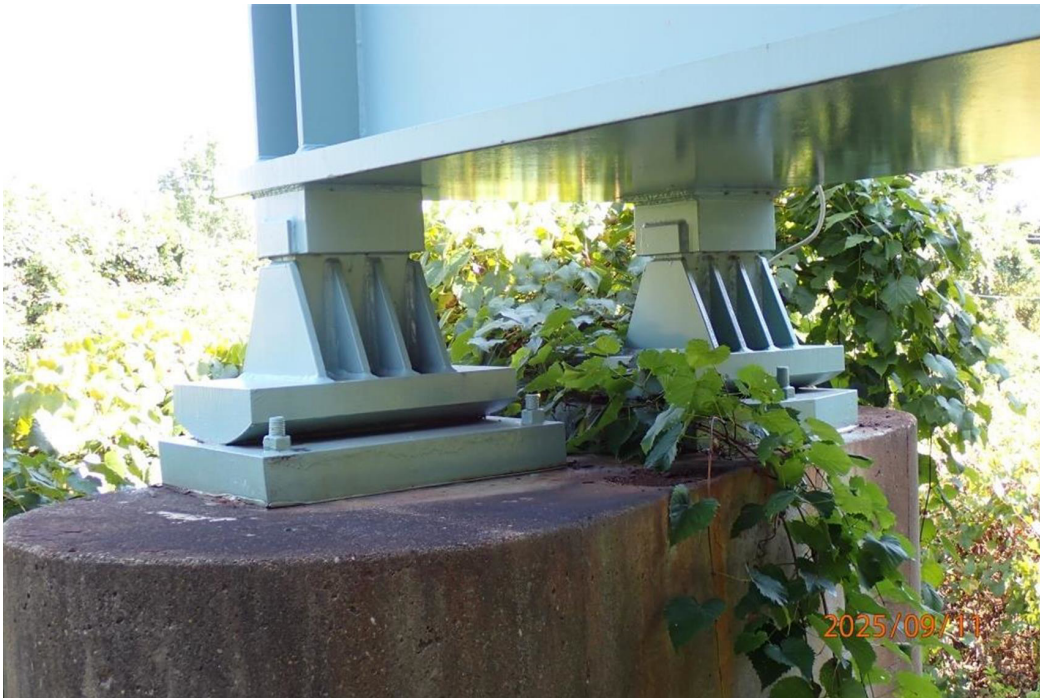
PHOTO 20

Description Pier 4 bearings at the west end (looking northwest)

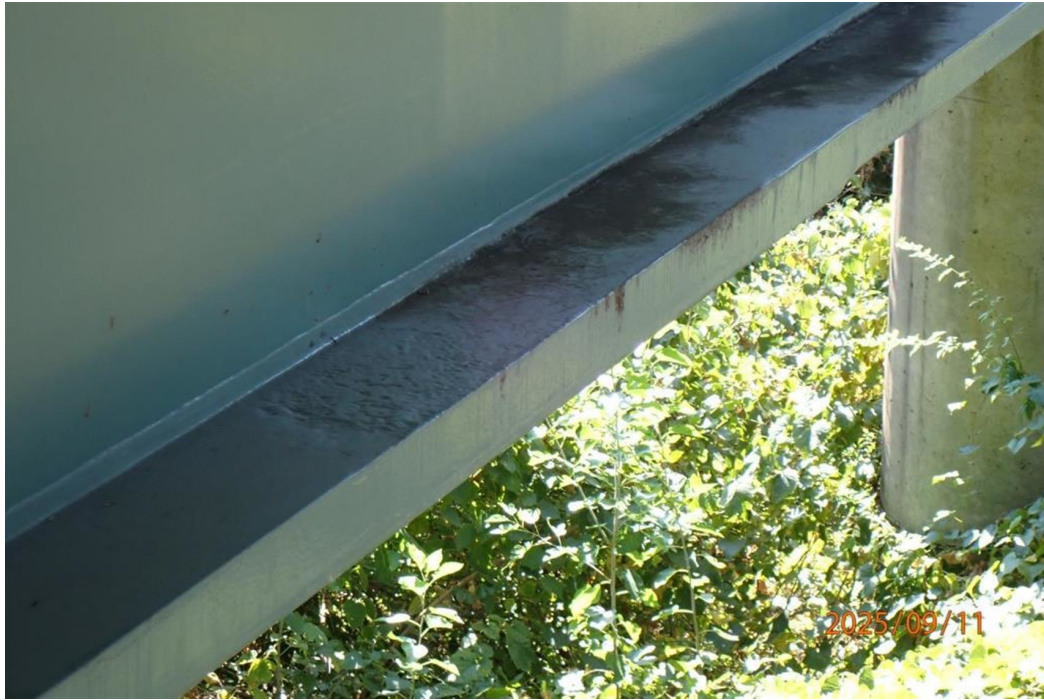
PHOTO 21

Description 1/8" painted over pitting to the Pier 4 south bottom flange under Girder 8 (looking northeast)

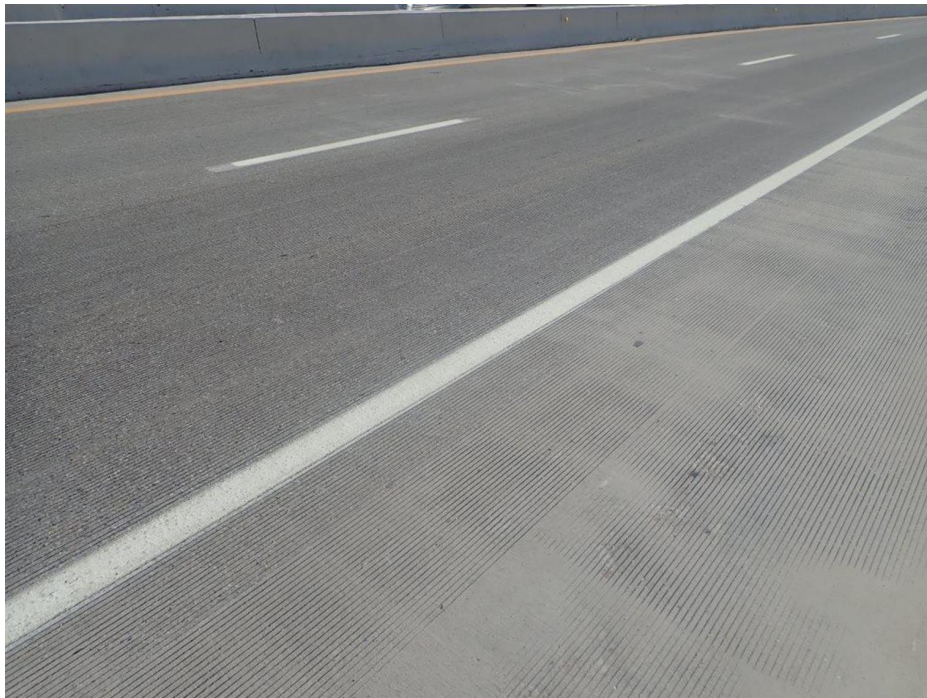
PHOTO 23

Description Typical view of the deck, southbound lanes of Span 6 shown (looking southeast)

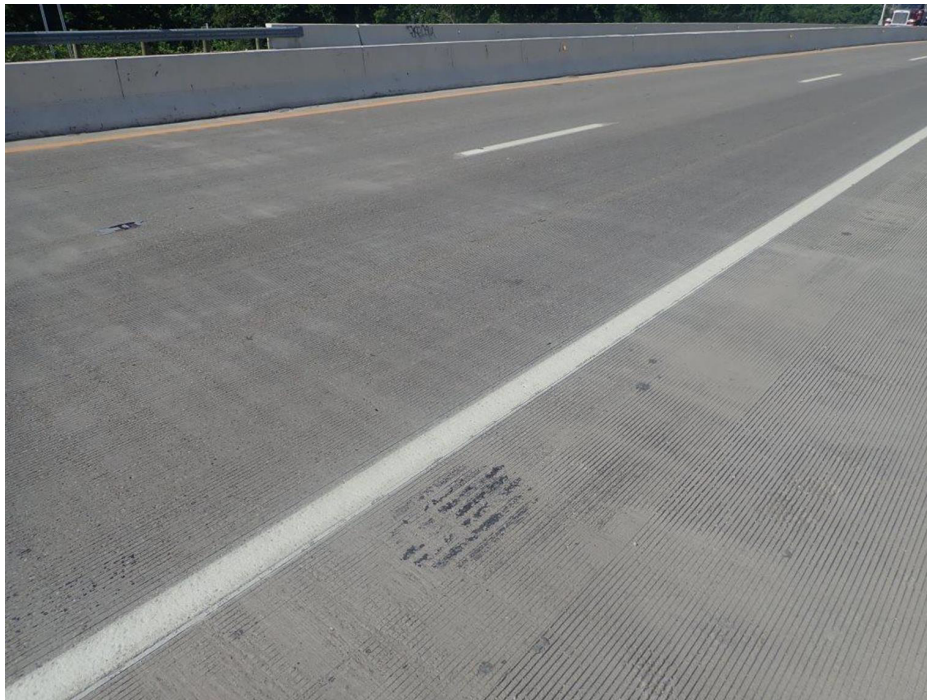
PHOTO 24

Description Typical view of the deck, southbound lanes of Span 7 shown (looking southeast)

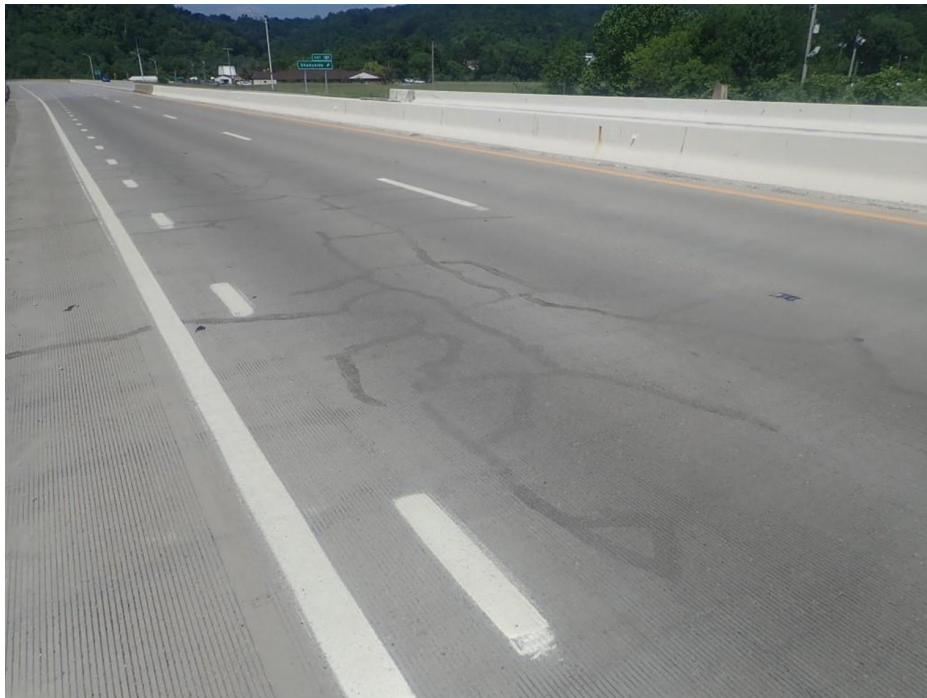
PHOTO 25

Description Typical view of the deck, northbound lanes of Span 3 shown (looking southwest)

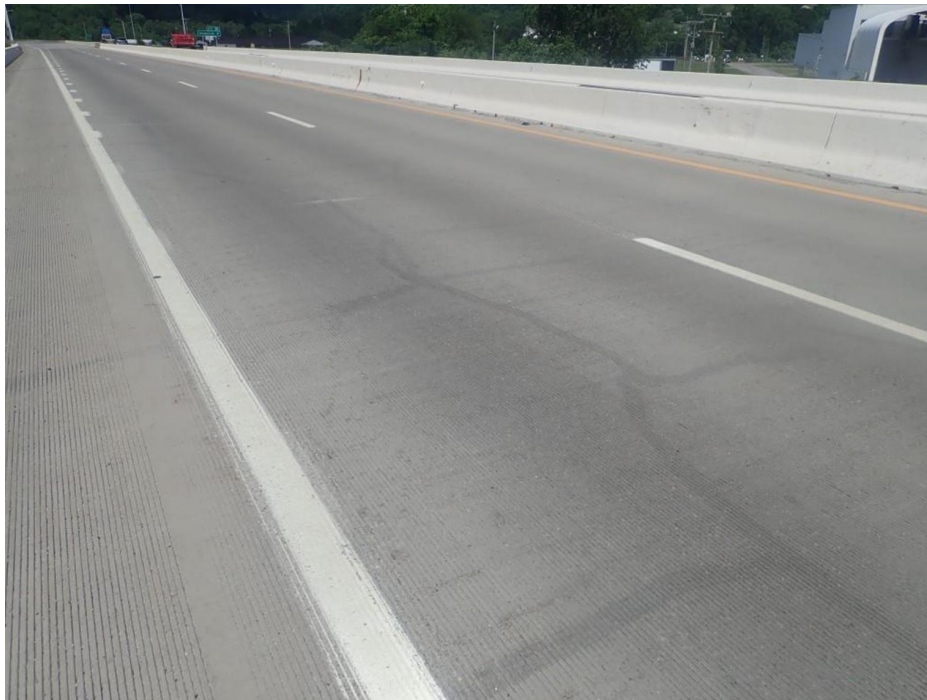
PHOTO 26

Description Typical view of the deck, northbound lanes of Span 6 shown (looking southwest)

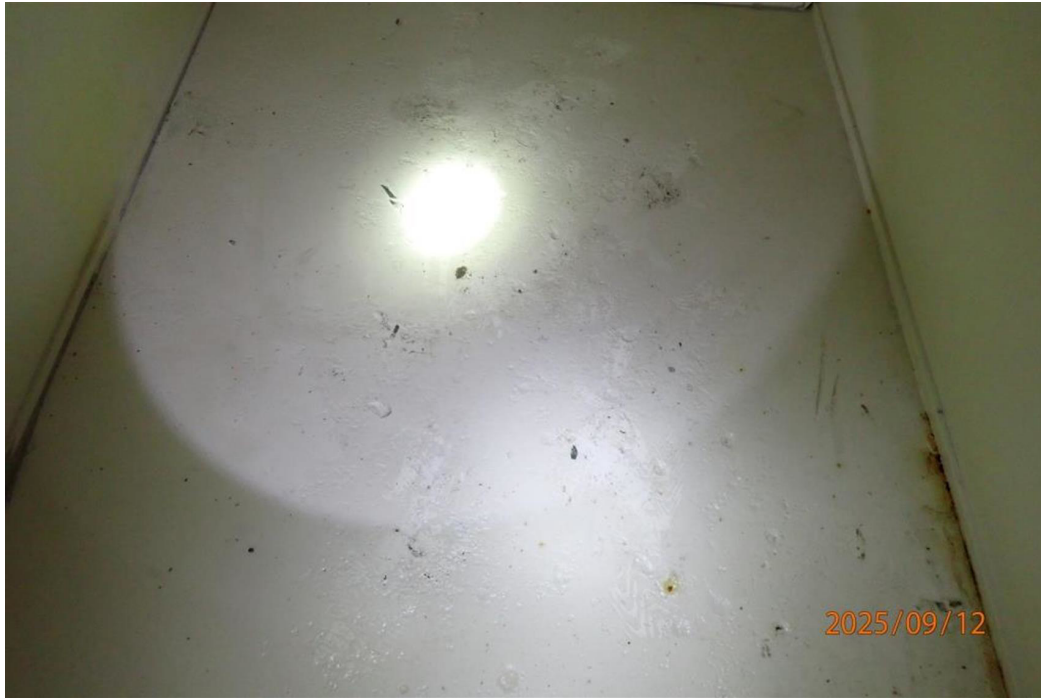
PHOTO 26

Description 1/8" deep painted over pitting in the top of the bottom flange between Diaphragms 3-4 inside Pier 4 (looking east)

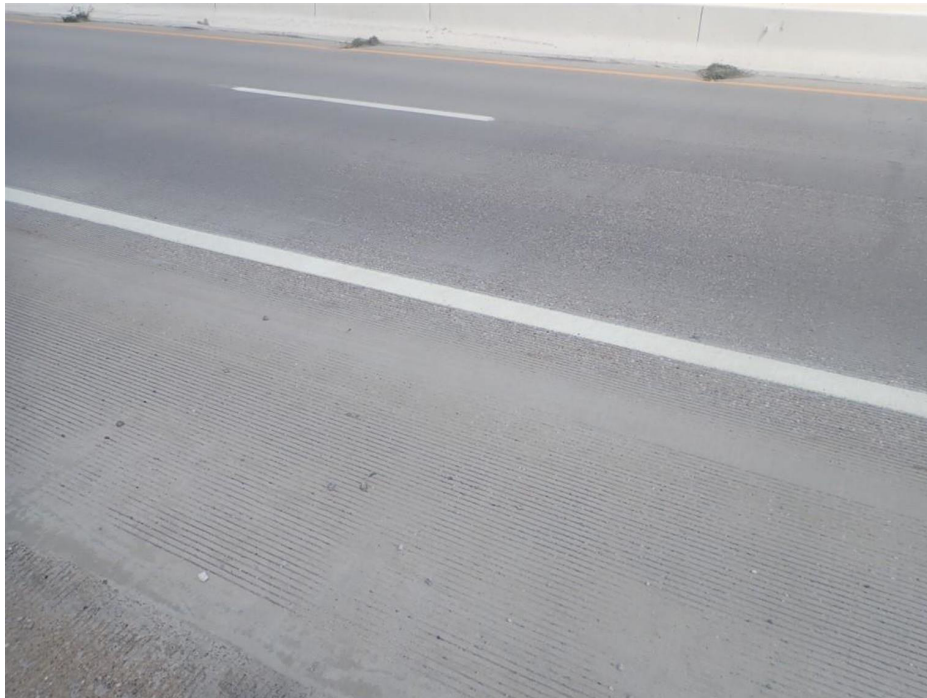
PHOTO 27

Description Typical view of the deck, northbound lanes of Span 7 shown (looking southwest)

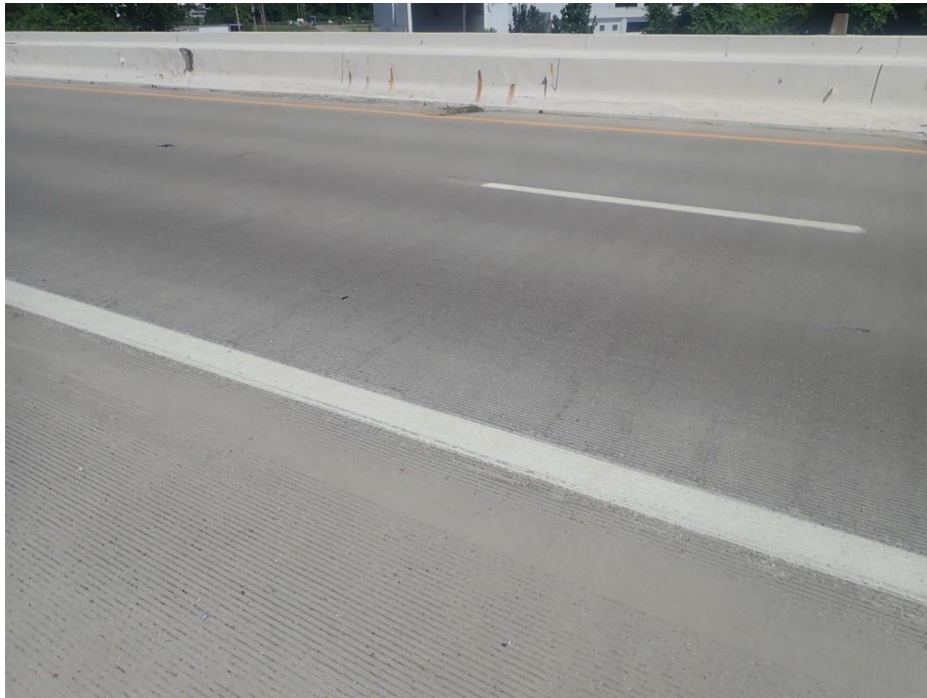
PHOTO 28

Description Typical view of the deck, northbound lanes of Span 6 shown (looking southwest)

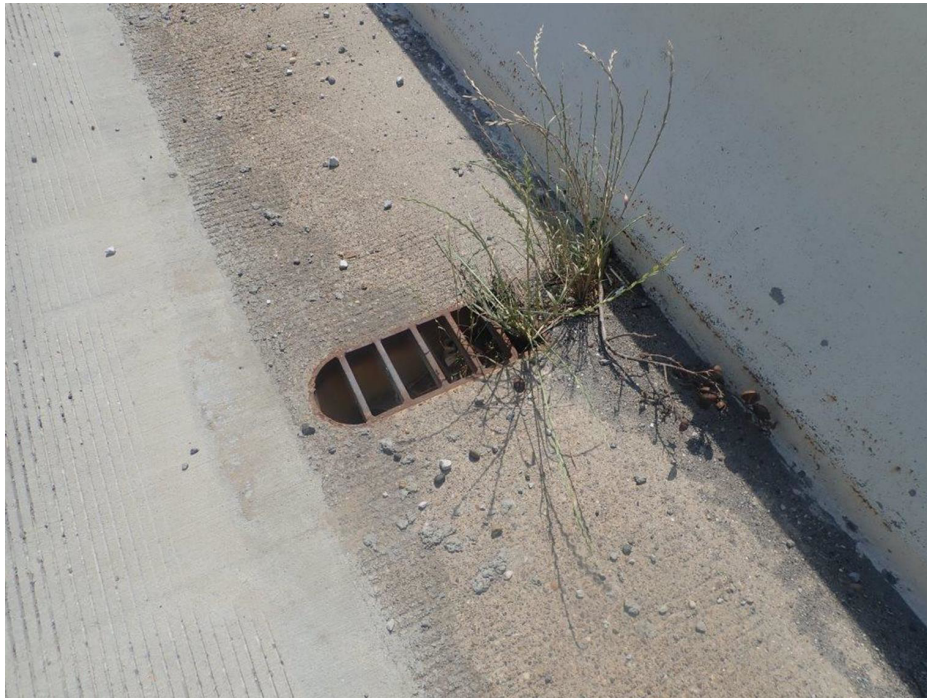
PHOTO 29

815-Drainage	3 - Mod.	27	each	0	27	0	0
Initiated rust on the undersides. CS2: - Many partially clogged scuppers with dirt & debris buildup in the shoulders (27 EA). The downspouts are clear.							
830-Abutment Backwall	3 - Mod.	150	ft.	115	35	0	0
CS2: - Medium width vertical cracks at both abutments. Hairline transverse cracks in direct traffic backwalls (35 LF).

Description Partially clogged scupper, 2nd scupper from forward end of the northbound lanes (looking north)

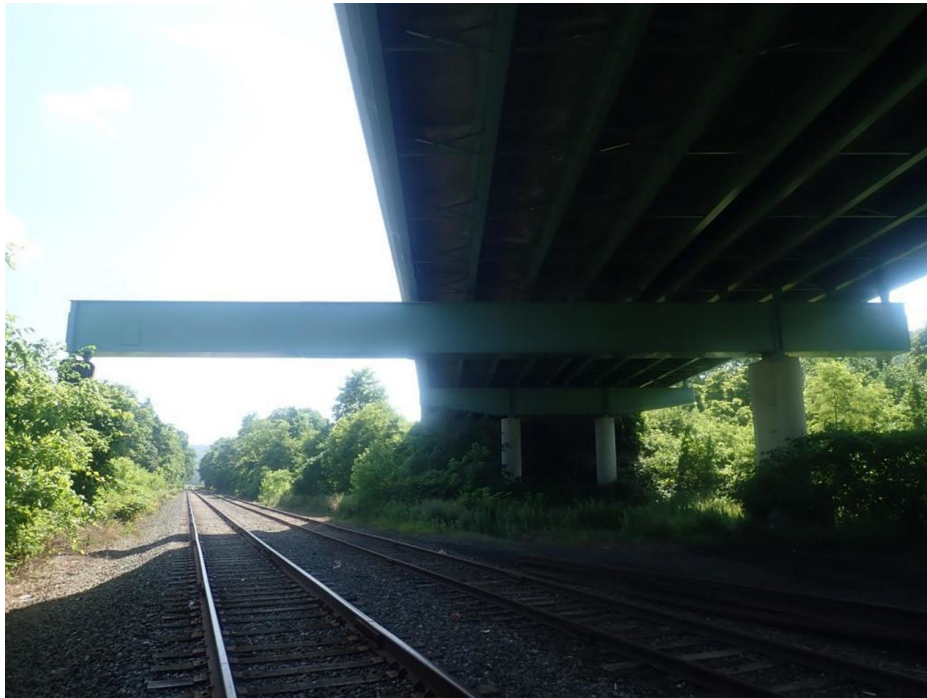
PHOTO 30

Description Pier 5, south elevation (looking north)

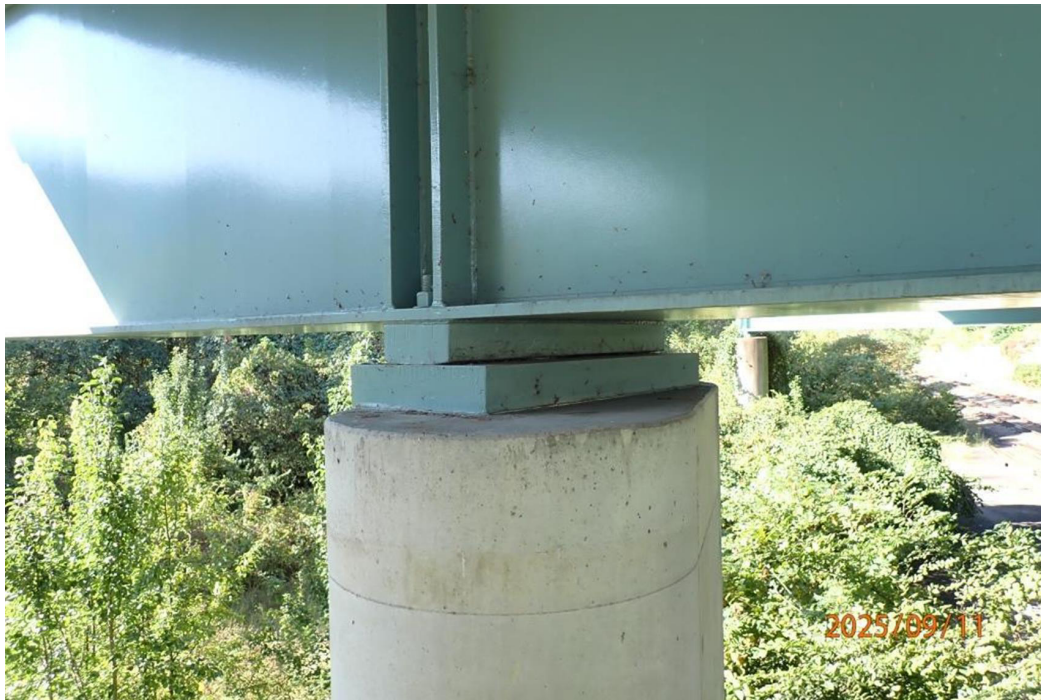
PHOTO 33

Description Pier 5 bearing sits skewed over Column 2 (looking southeast)

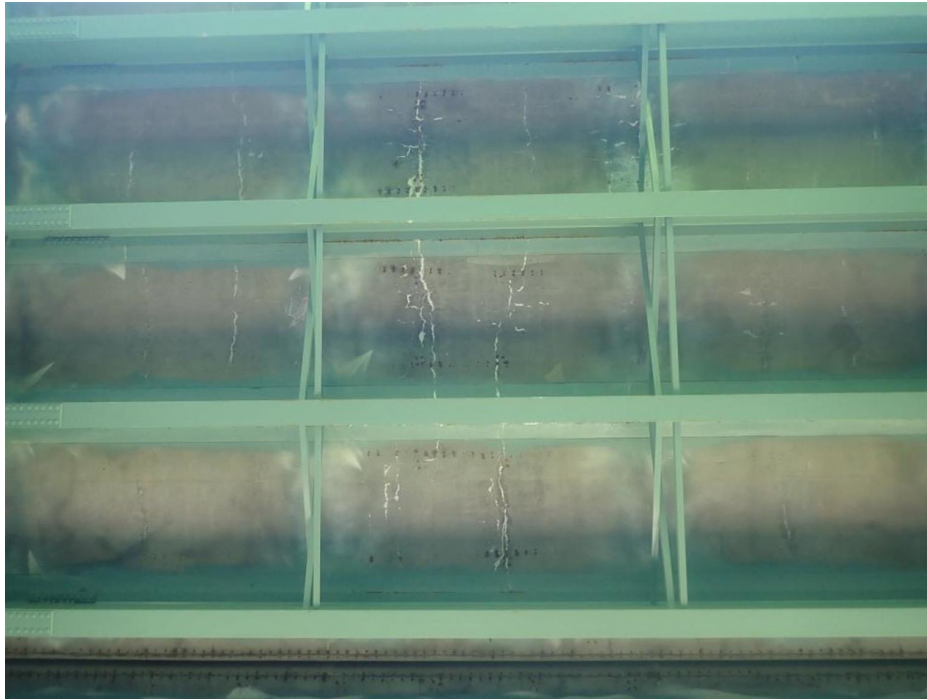
PHOTO 35

Description Span 3 underside of the deck, southbound lanes (looking east)

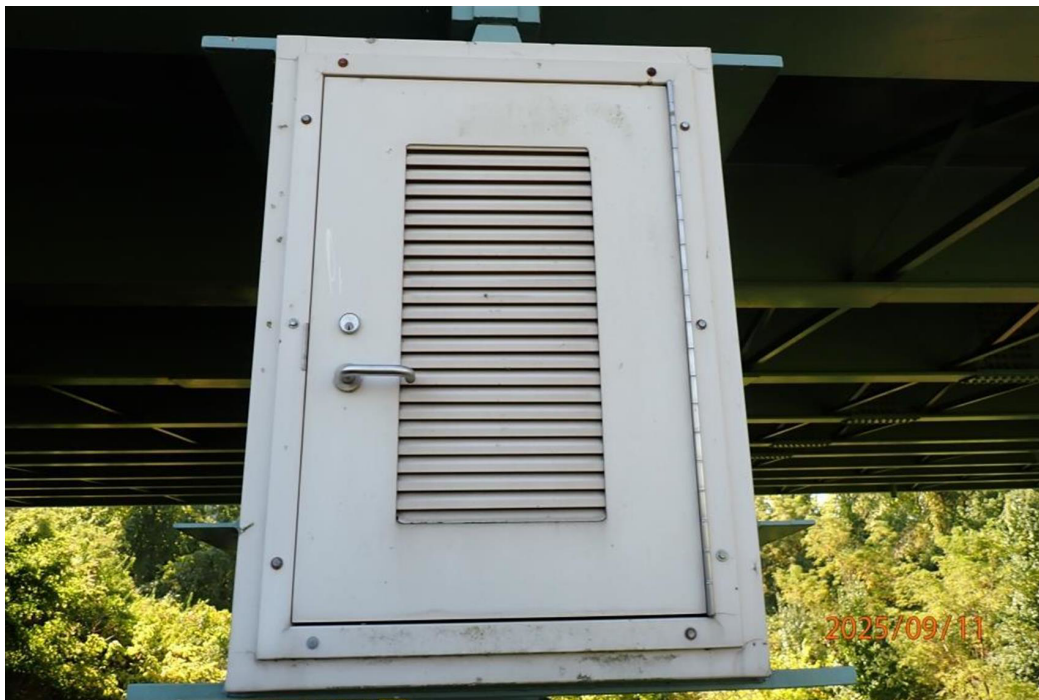
PHOTO 36

Description Typical access hatch, west end of Pier 6 shown (looking east)

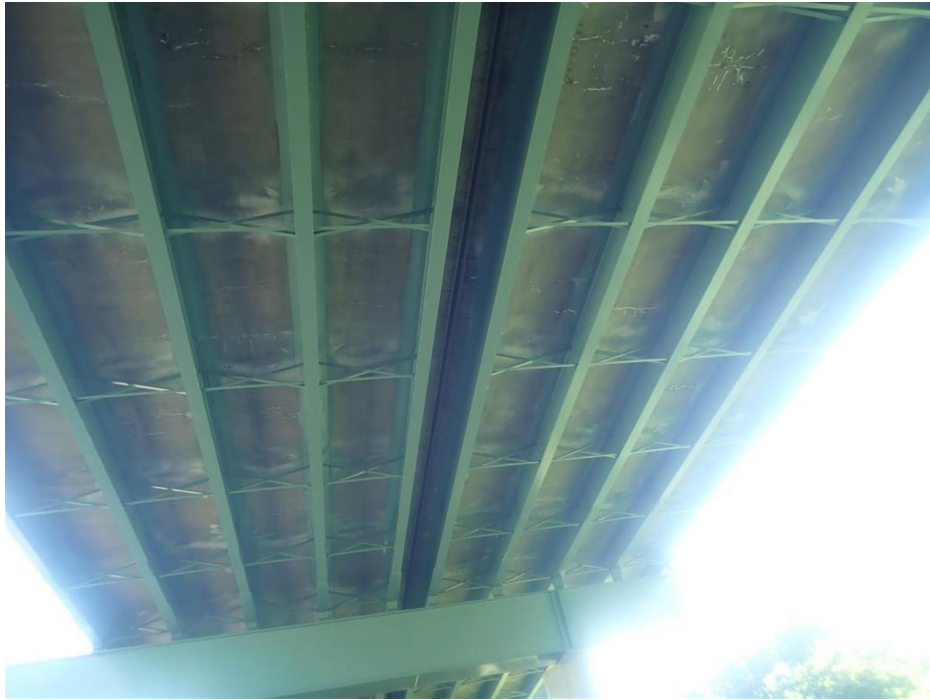
PHOTO 36

Description Span 4 underside of the deck (looking north)

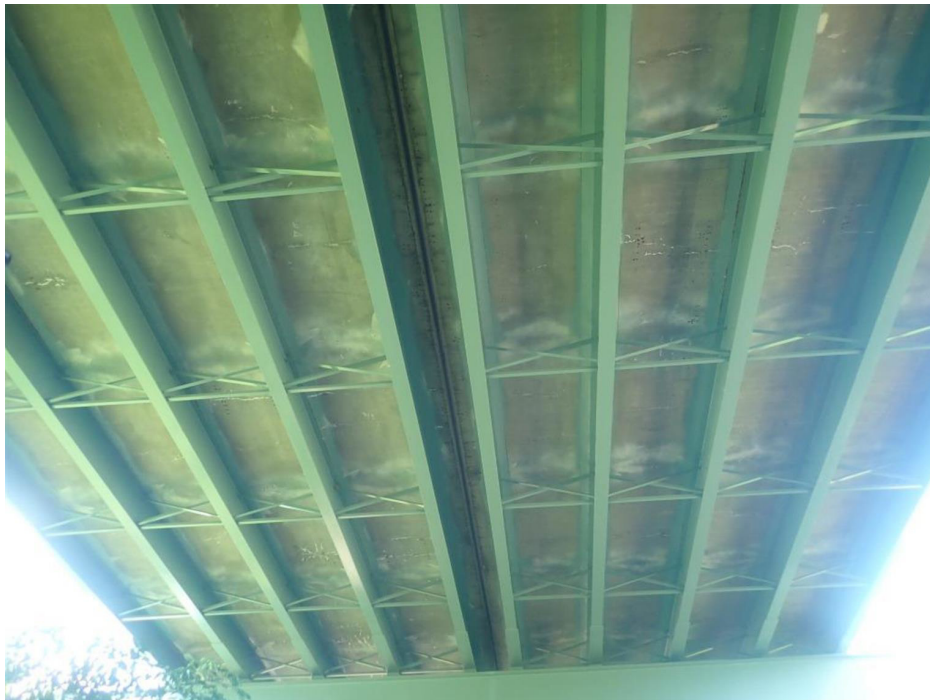
PHOTO 37

Description Span 4 underside of the deck (looking south)

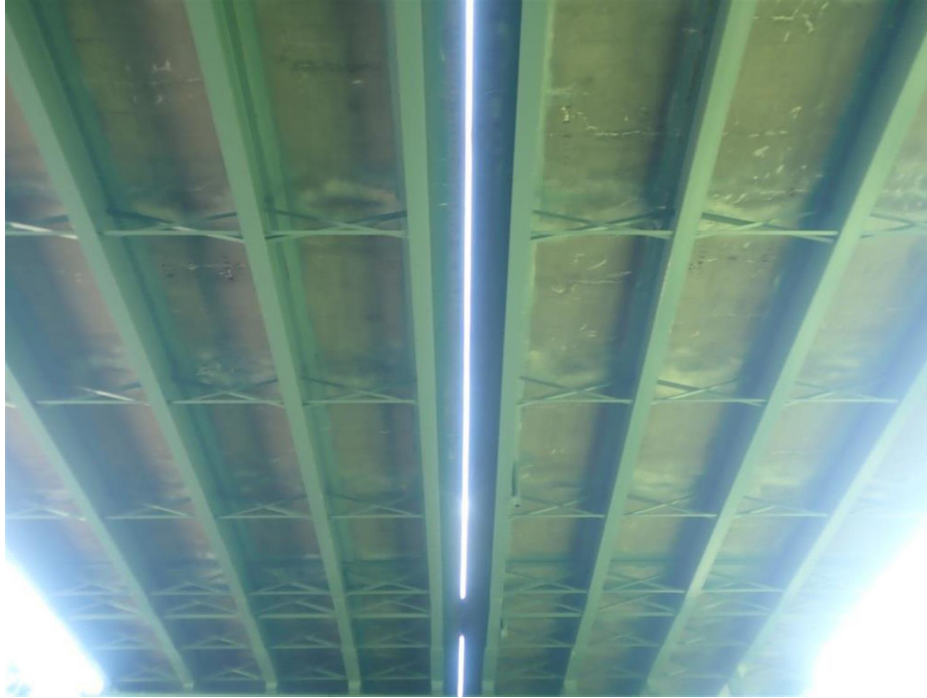
PHOTO 38

Description Span 5 underside of the deck (looking north)

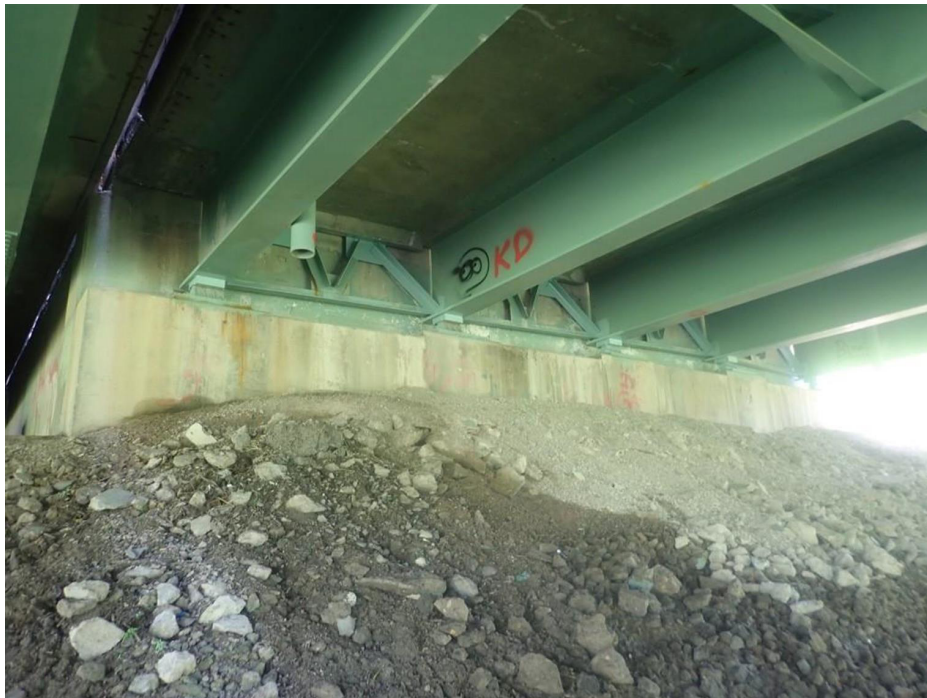
PHOTO 39

Description Forward Abutment, south elevation, northbound lanes (looking north)

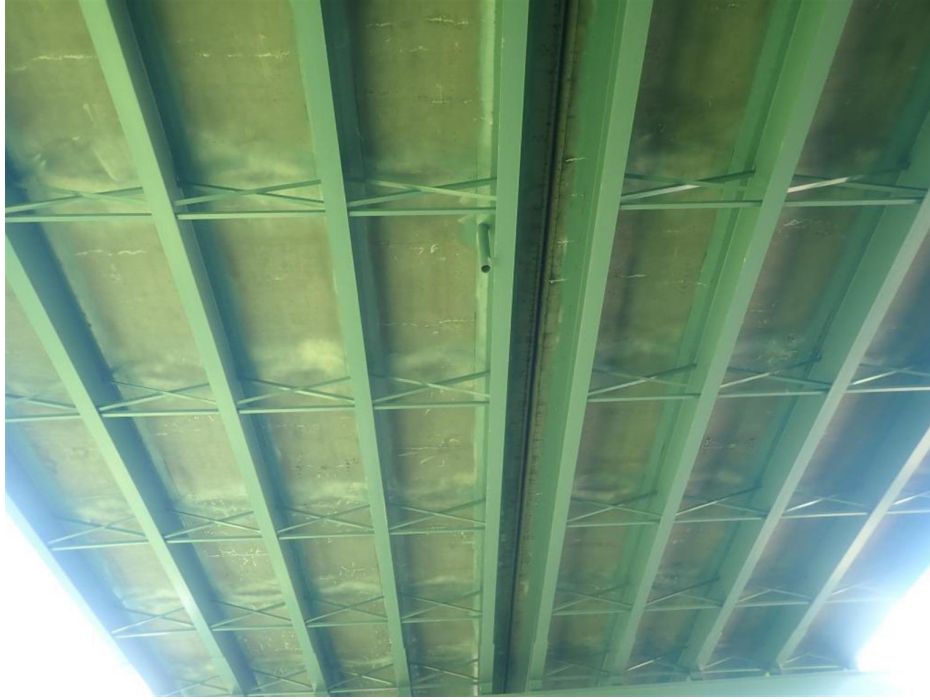
PHOTO 39

Description Span 5 underside of the deck (looking south)
