Structure Number: 0700312

Facility Carried: SR 7

Ohio Bridge Inspection Summary Report

BEL-00007-1187 (0700312)

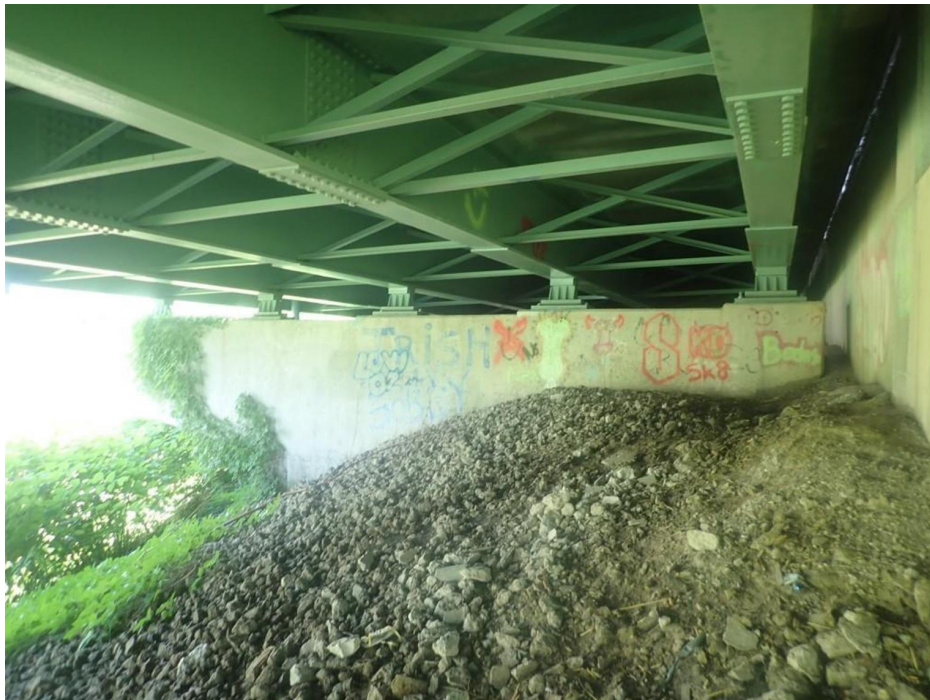
PHOTO 40

Description Pier 7, south elevation, southbound lanes (looking north)

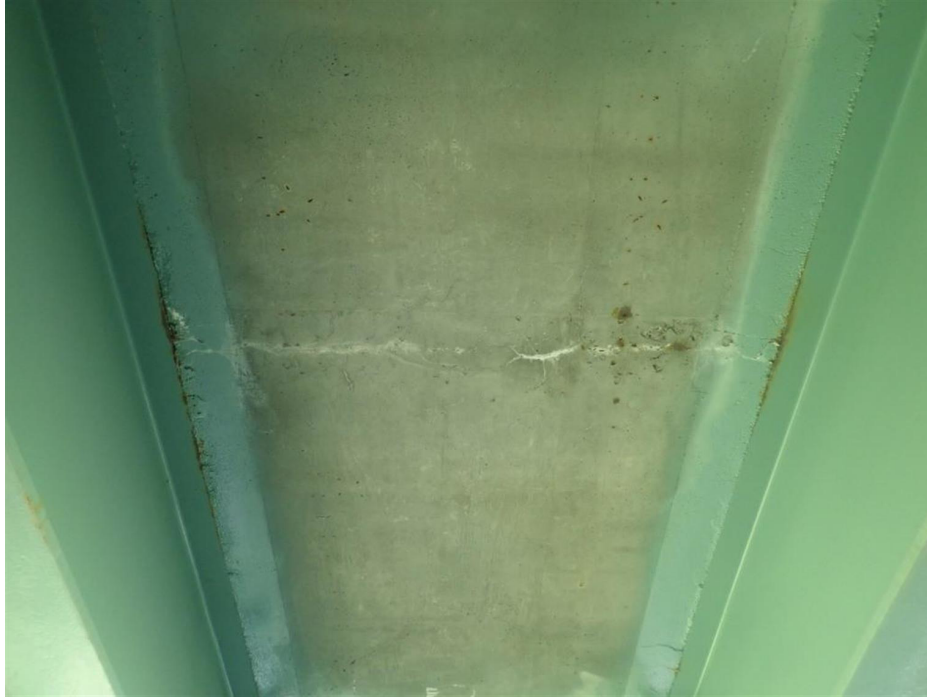
PHOTO 40

Description Transverse cracking with efflorescence in the deck underside between Beams 7-8 in Span 6 (looking south)

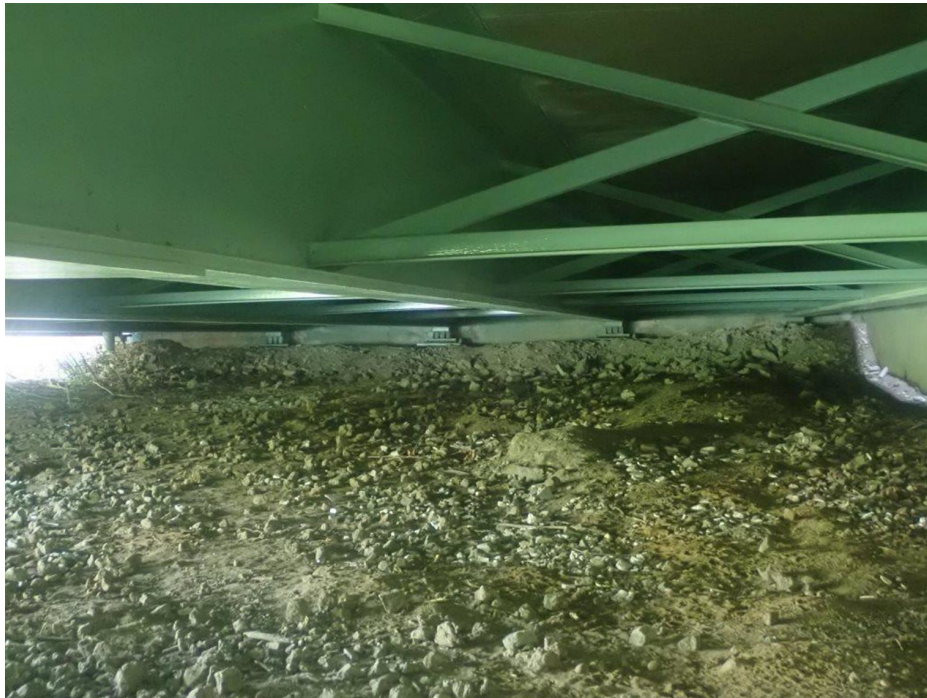
PHOTO 41

Description Forward Abutment, south elevation, southbound lanes (looking north)

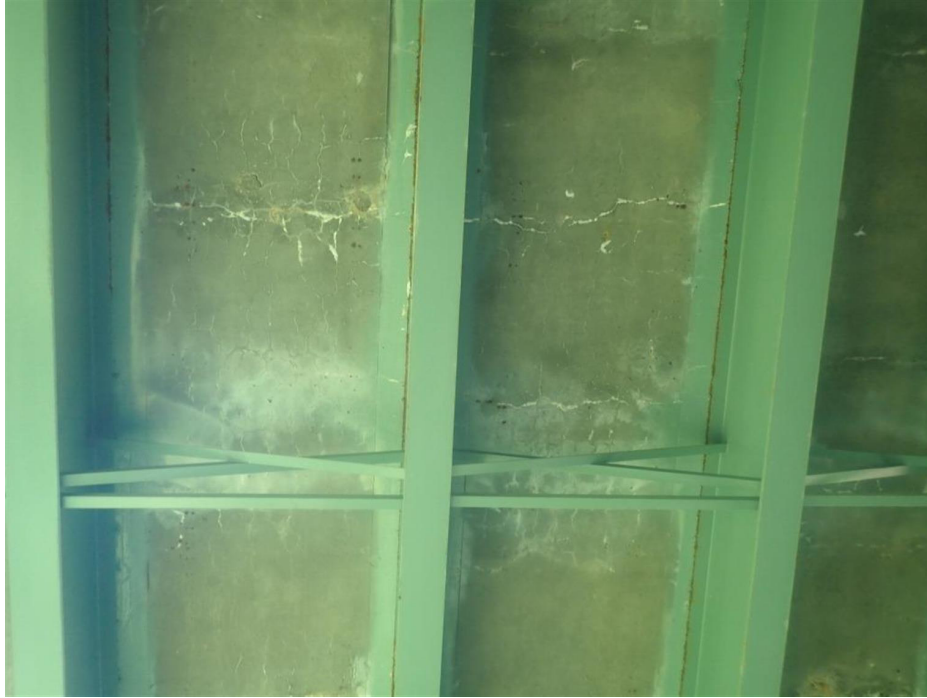
PHOTO 41

Description Transverse cracking in the deck underside of Span 6 (looking north)

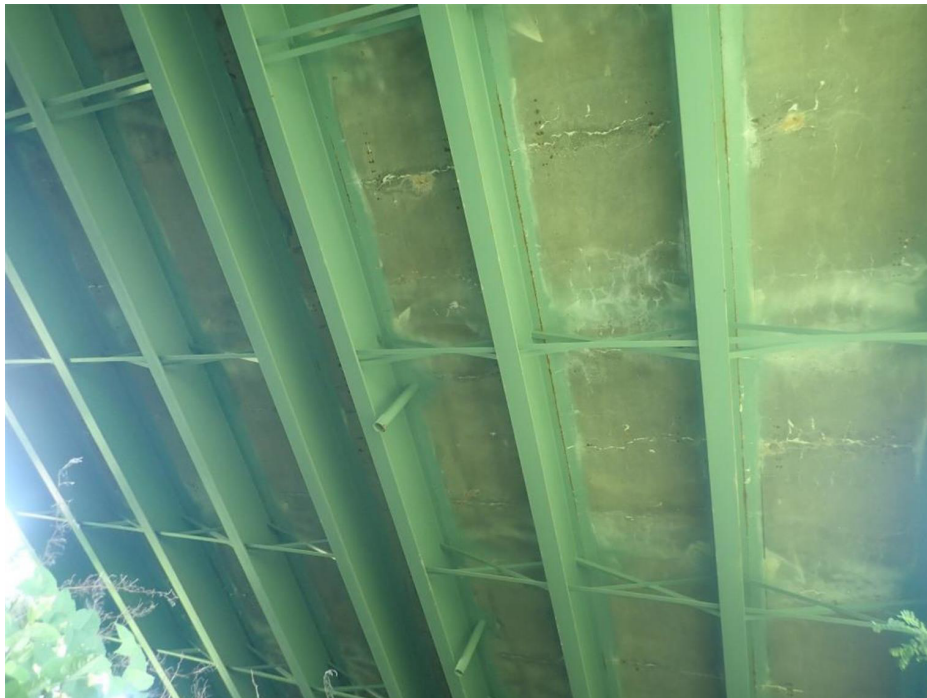
PHOTO 42

Description Transverse cracking in the deck underside of Span 6 (looking northwest)

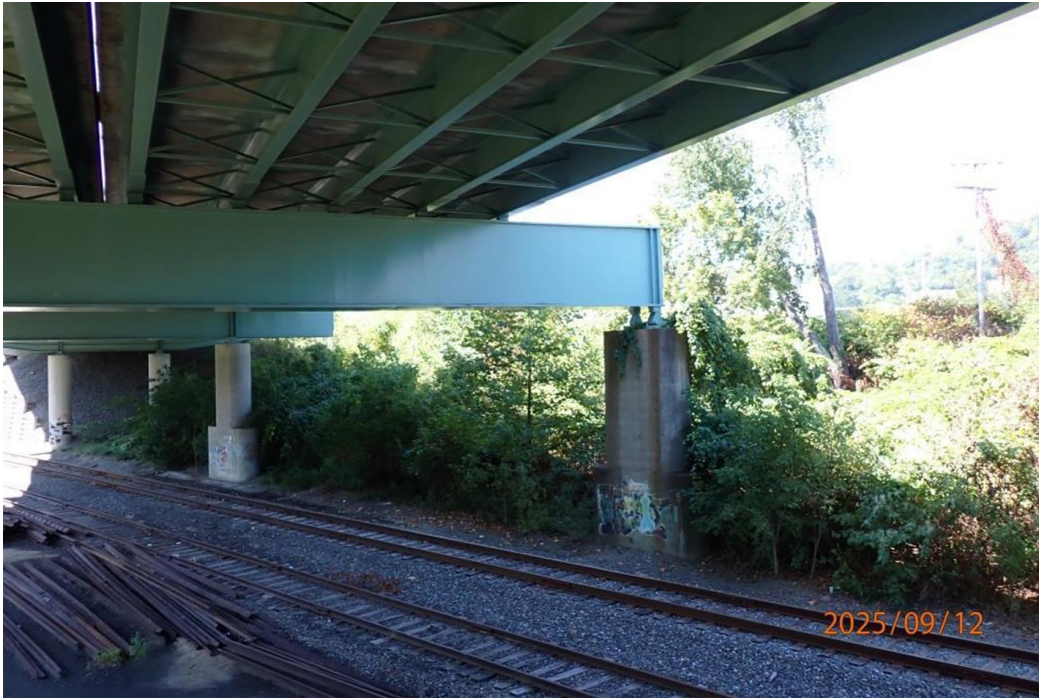
PHOTO 42

Description Heavy vegetation on the west side of the bridge between Spans 2-3 impacting access by UBIV (looking southwest)

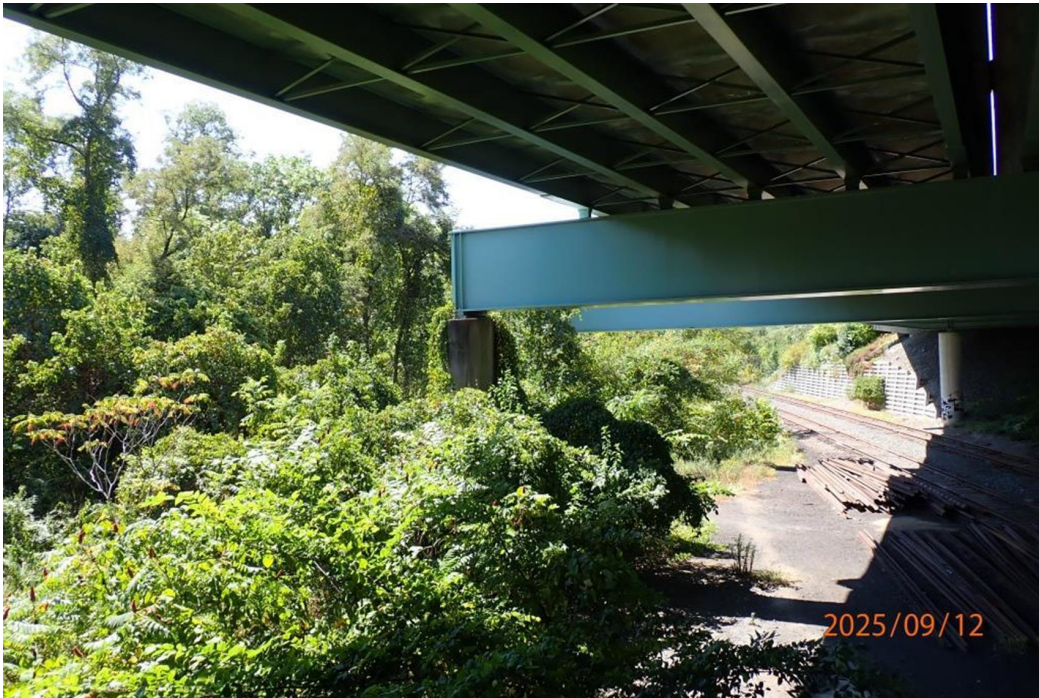
PHOTO 43

Description Heavy vegetation on the east side of the bridge between Spans 2-3 impacting access by UBIV (looking southeast)
