## **2012 In-Depth Inspection Report**

### **I-71/SR 176 Double Decker Bridge – (I-71 Upper Deck)**

**CUY-00071-1791  
(SFN 1805371)**

**Inspection Dates: 07/30/2012 to 08/10/2012**

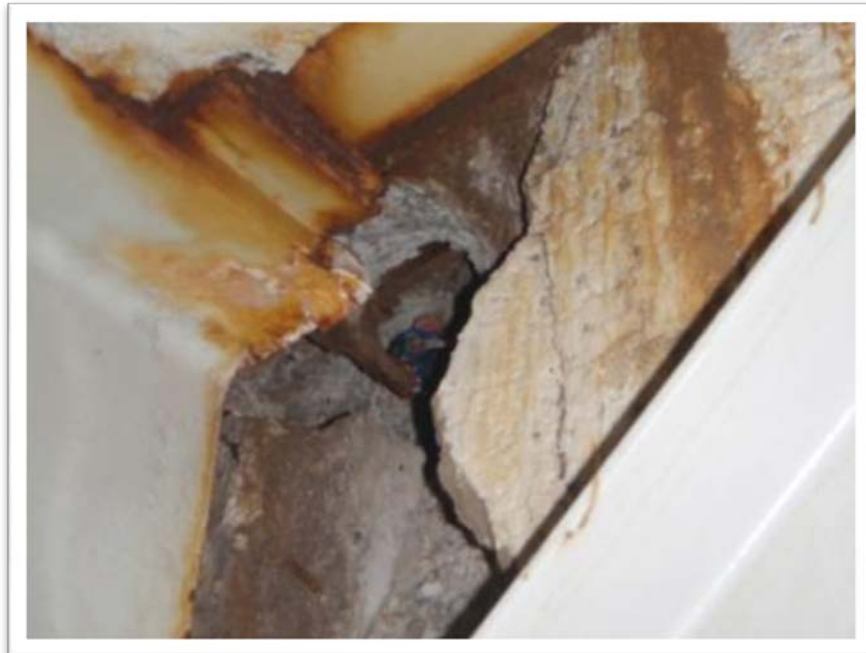
- North Abutment AW – The northeast corner has a hole measuring 1 ½' x 1 ½'.
