2012 In-Depth Inspection Report

I-71/SR 176 Double Decked Bridge – (SR 176 Lower Deck)

**CUY-00176-1334
(SFN 1805436)**

Inspection Dates: 07/30/2012 to 08/10/2012

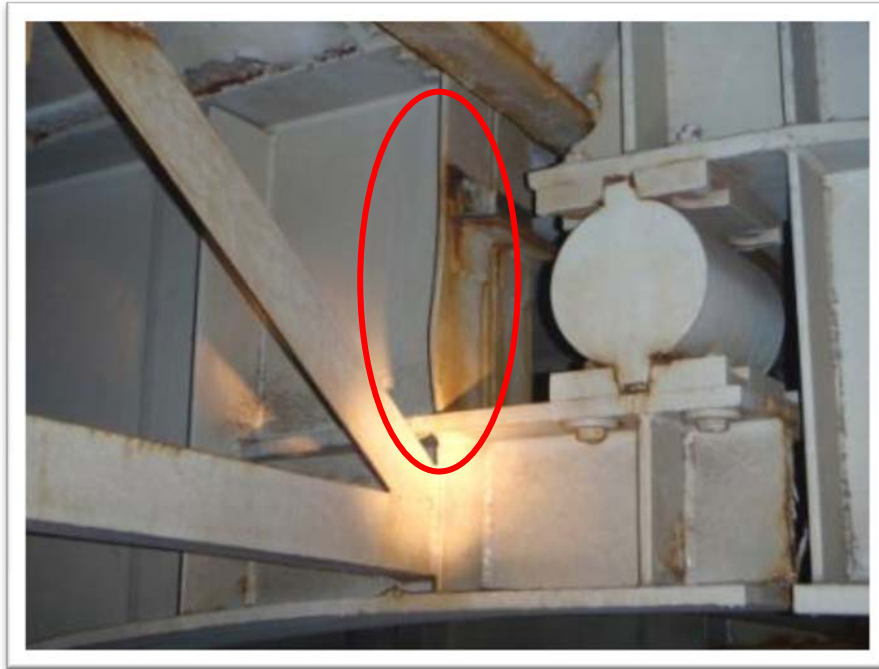
- The end of Beam B, at the cope, in Span 7 is bent.
