PHASE I ENVIRONMENTAL SITE ASSESSMENT

PORTSMOUTH BYPASS PROJECT
SCI-823, PID No. 19415

OHIO DEPARTMENT OF TRANSPORTATION

AUGUST 1, 2003

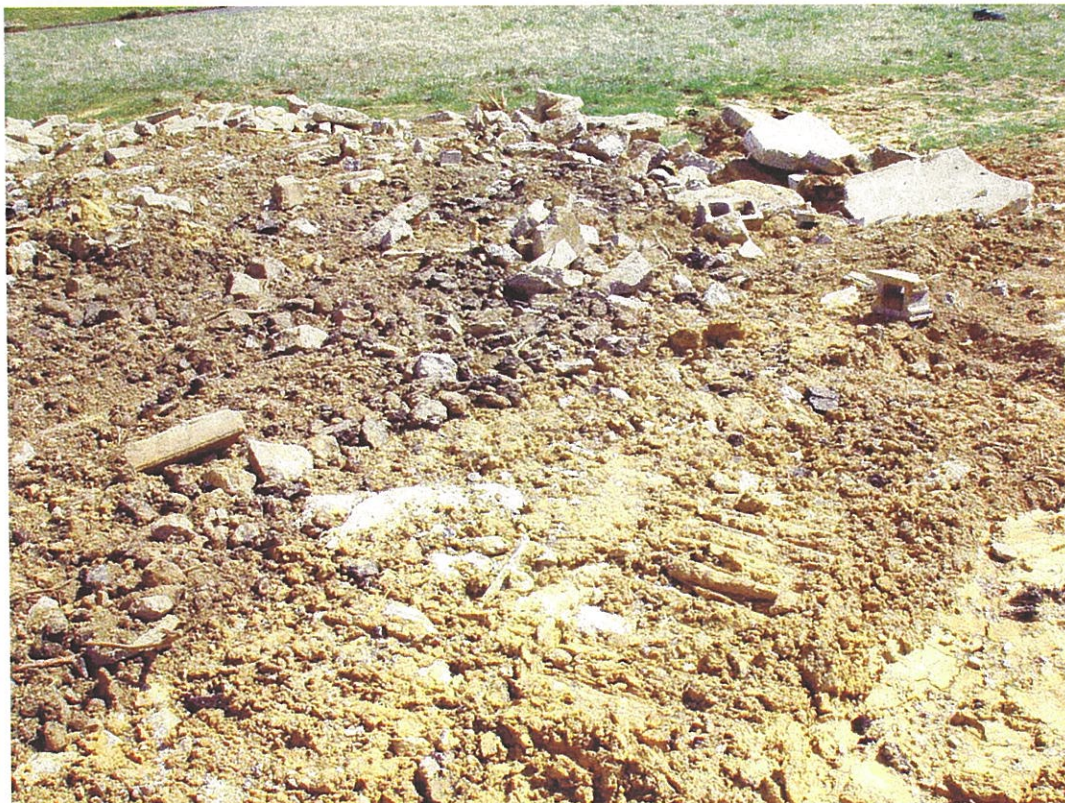
(PID 08-0401.002)

Photo 12. View looking at concrete debris located on the Turner property.

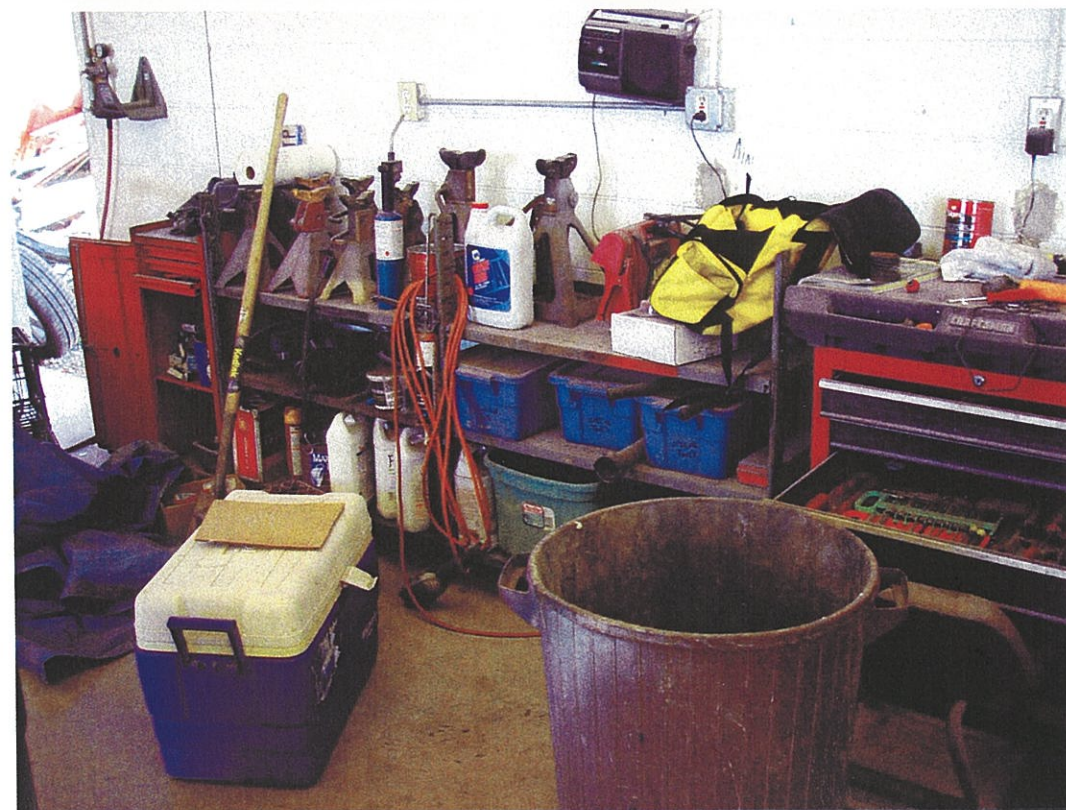
(PID 08-0401.002)

Photo 16. View of lubricants located in the auto repair building.

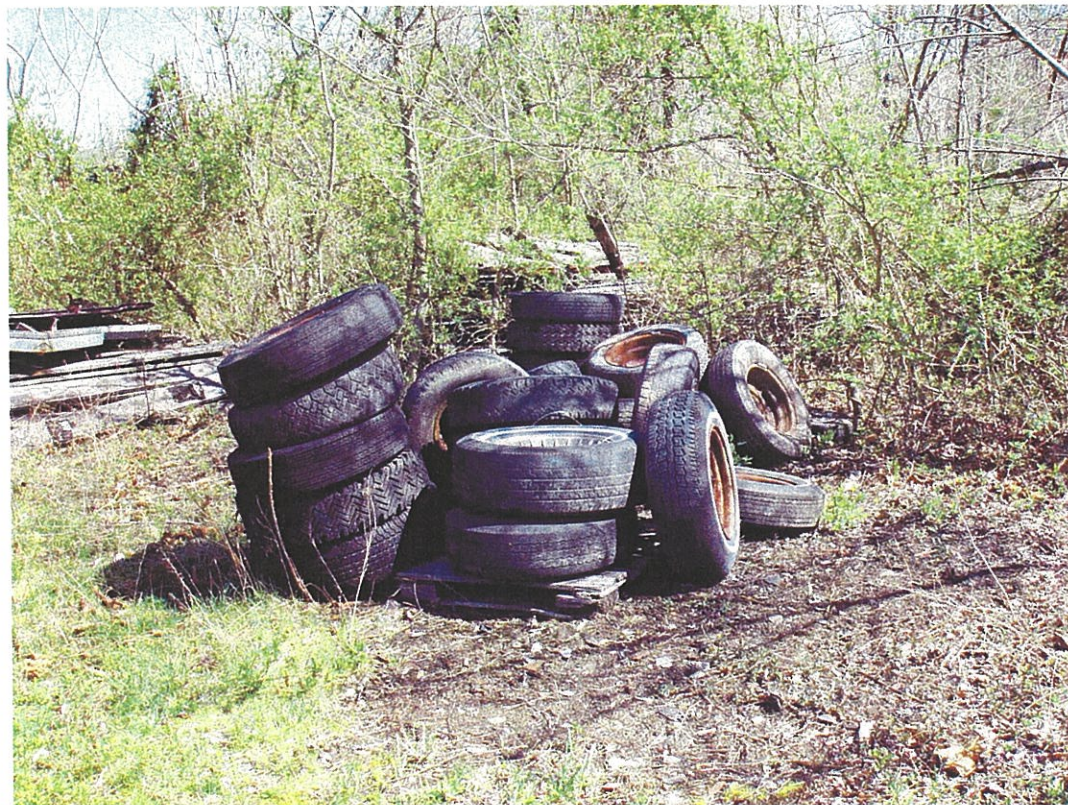
(PID 16-0839.000)

Photo 24. View looking at used tires located on the McGuire property.

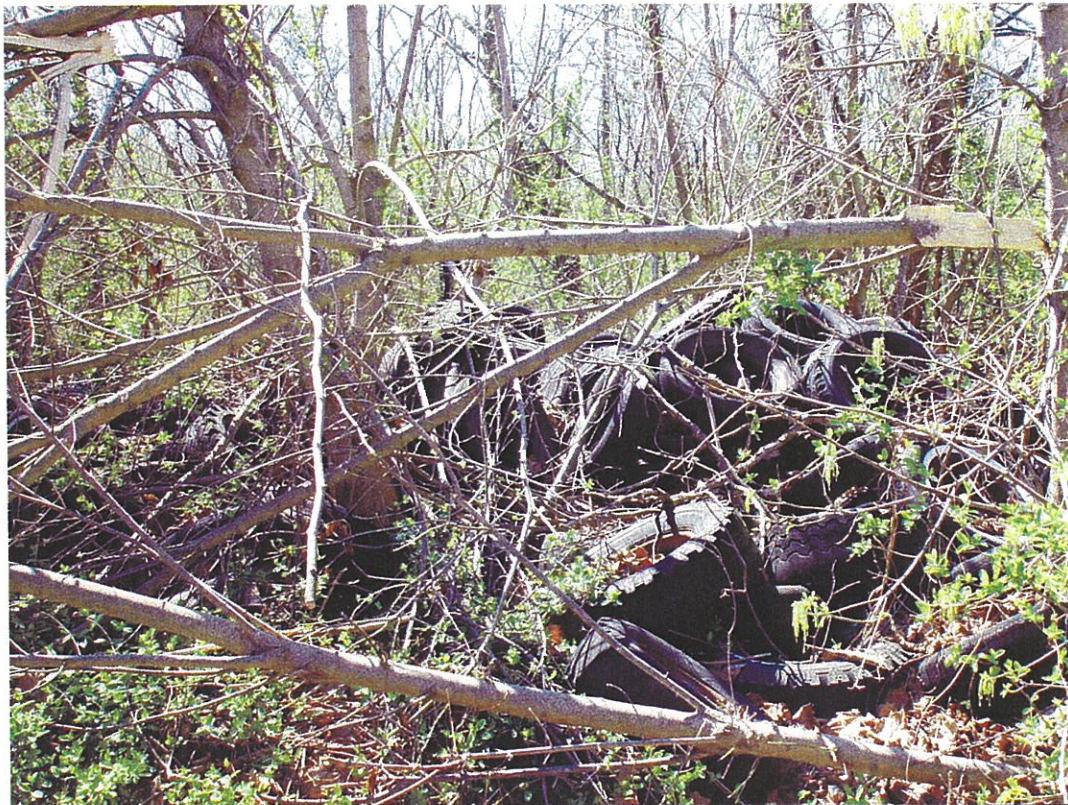
(PID 16-0837.000)

Photo 26. View looking at used tires located on the McGuire property.

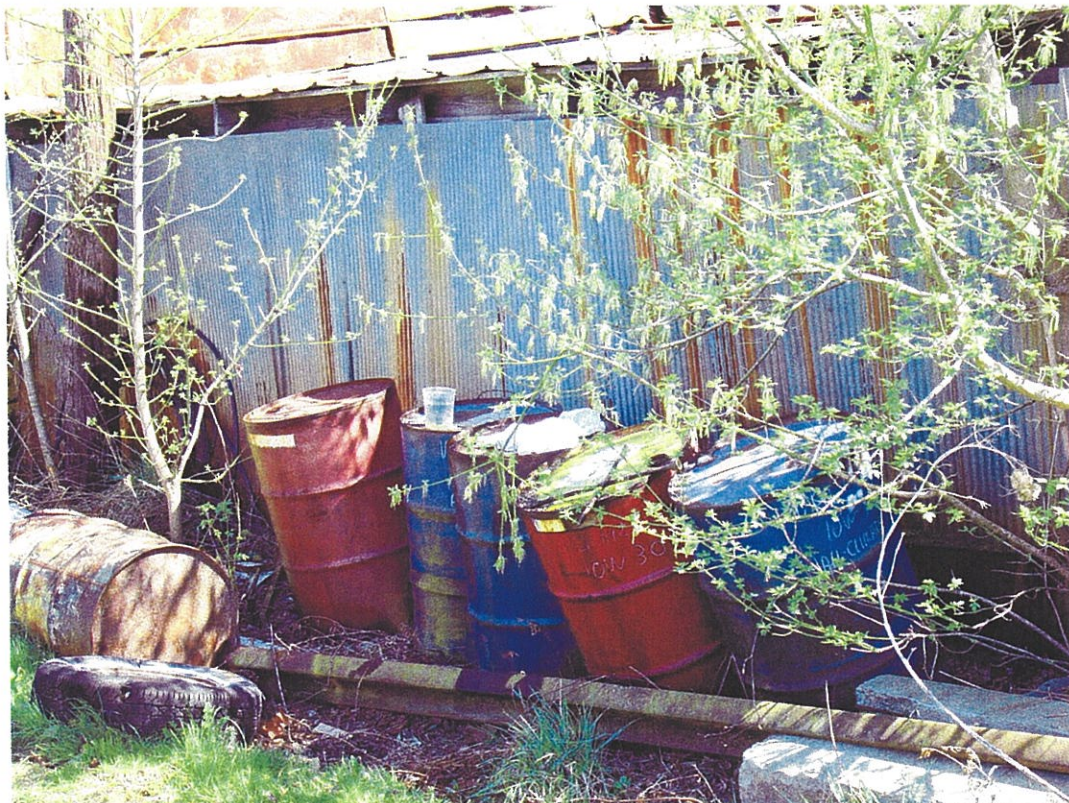
(PID 16-0845.000)

Photo 28. View looking at used petroleum drums located on the McGuire property.

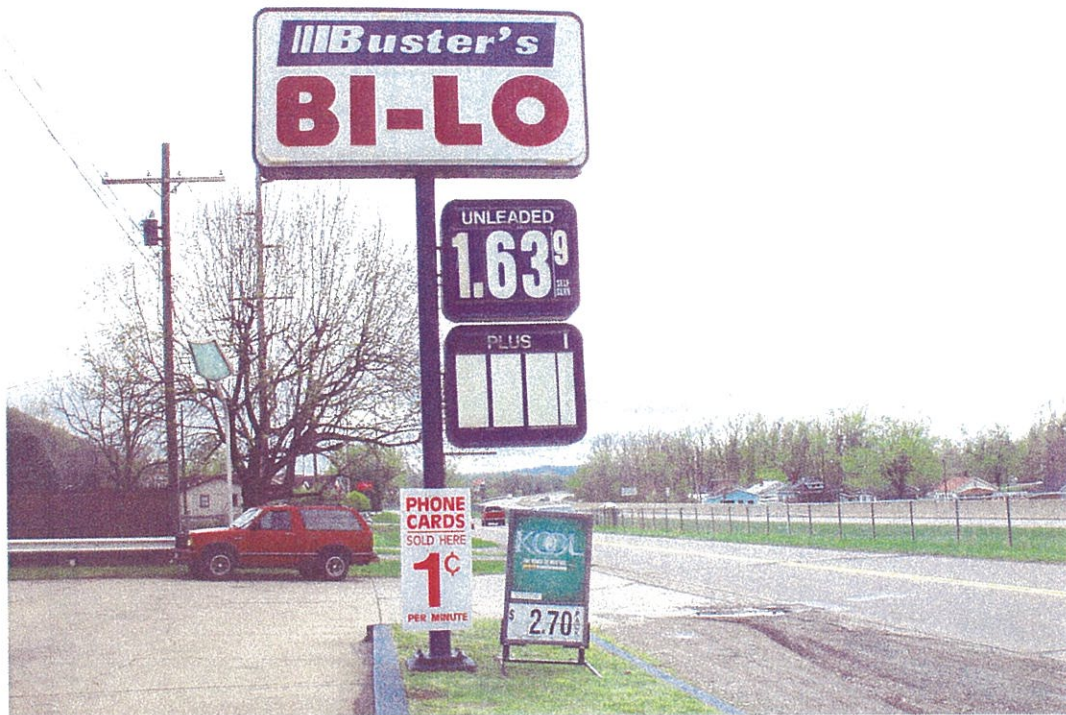
(PID 16-1471.000)

Photo 45. View of the Buster's Bi-Lo property looking east.

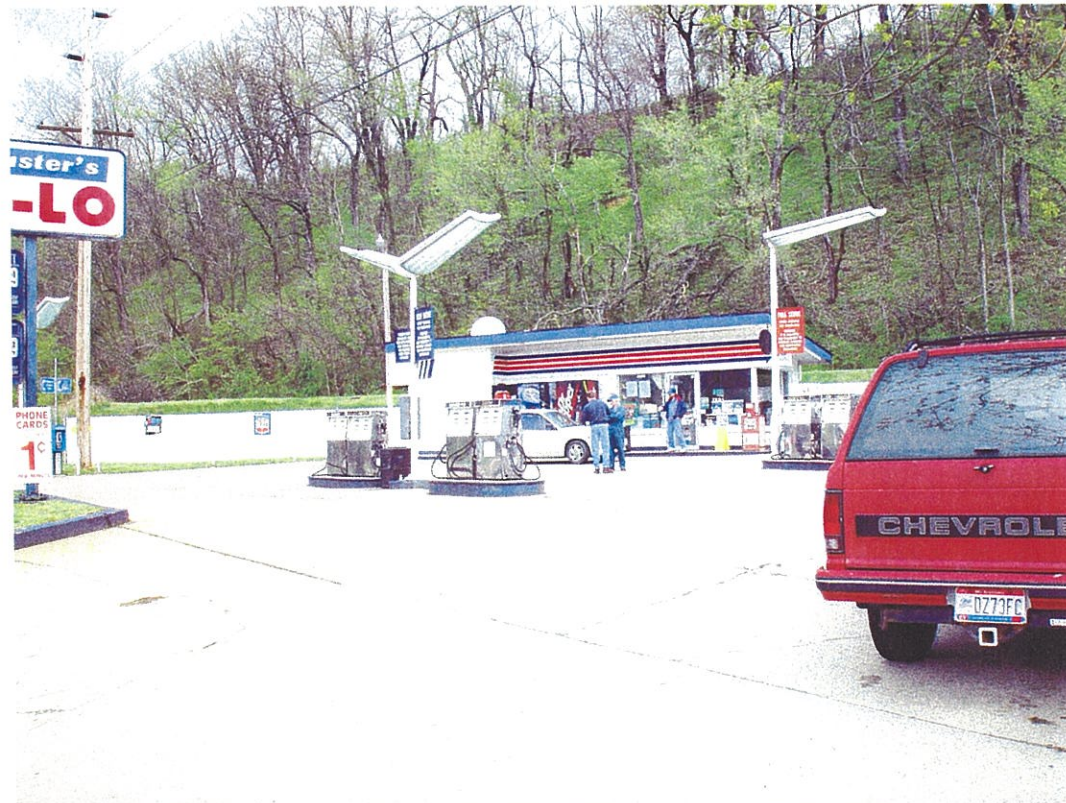
(PID 16-1471.000)

Photo 46. View of the Buster's Bi-Lo property looking northwest.

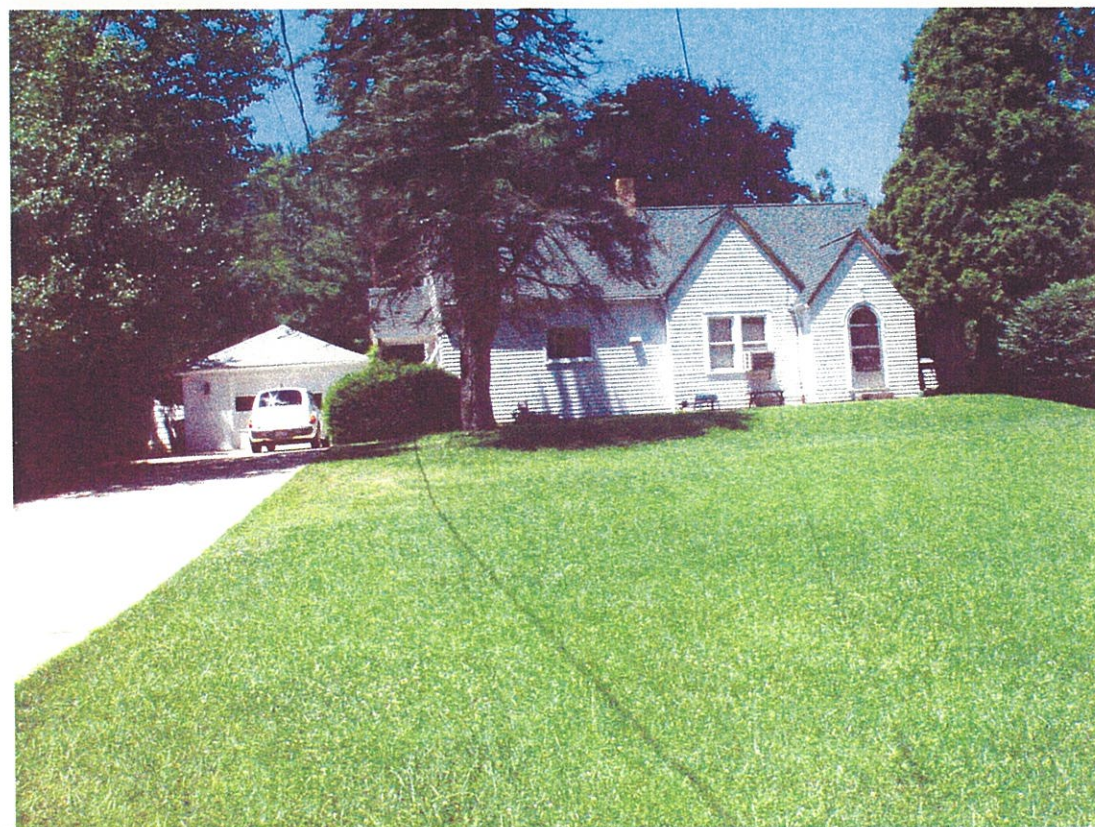
(PID 07-1374.002)

Photo 54. View looking at the Trowbridge residence.
