# **B&N Local Route Study** (Reference Document)

Innerbelt Bridge
Construction Contract Group 1 (CCG1)

CUY-90-15.24 PID No. 83680

# LOCAL ALTERNATE ROUTES STUDY

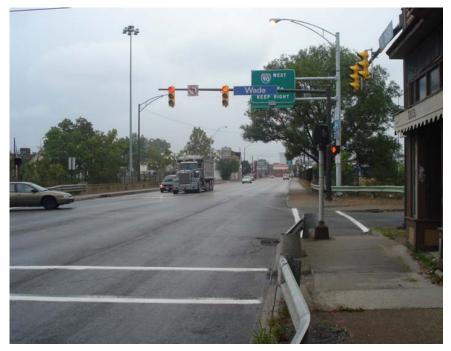
3

West 25th @ Wade Looking North

Damaged guardrail

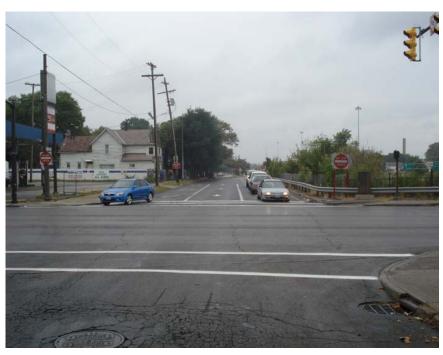
4

West 25th @ Wade Looking West

Showing alternative entrance to I-90 west-bound

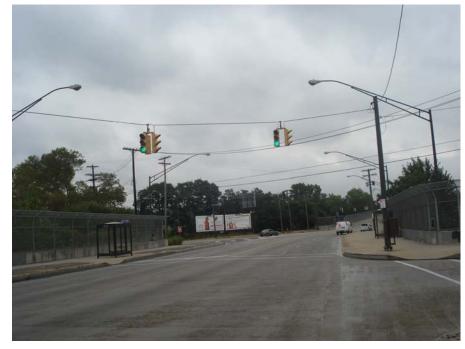
West 25th @ Monroe Looking South

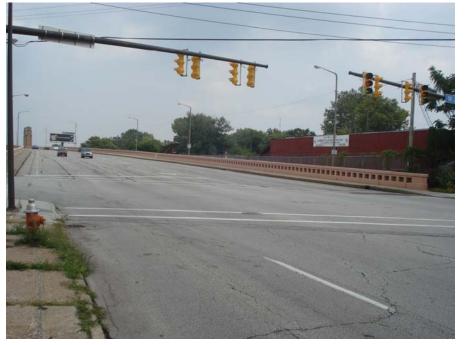
12

Lorain @ West 20th Looking West

Notes: Emergency vehicle use intersection.

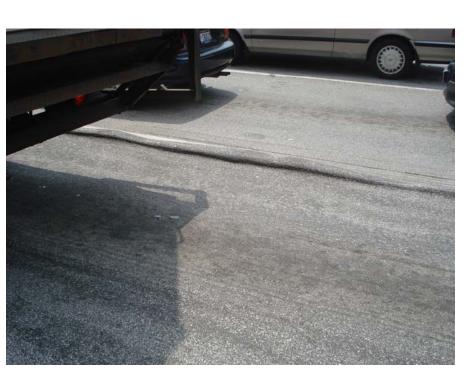
15

Ontario @ Lorain Looking East (from median)

Pavement is in poor condition of eastbound left –turn lane east of intersection

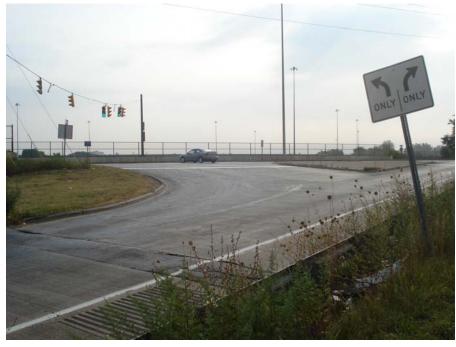
Tight left turn radius for trucks

Broadway @ IR-490 EB Exit Ramp Looking East

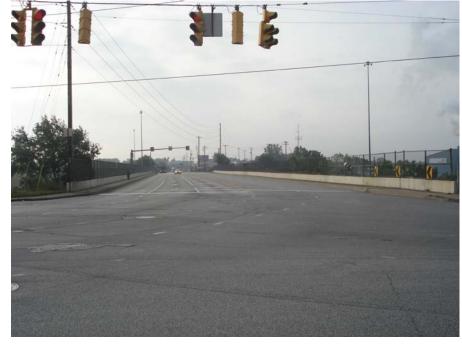
Need video detection for left turn lane on bridge

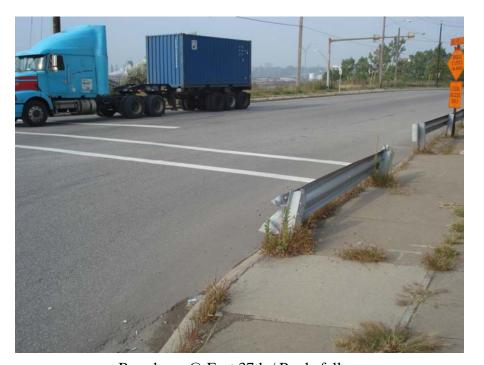
Damaged guardrail

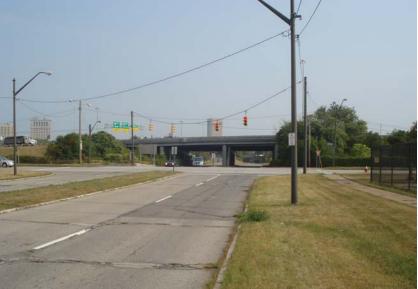
Notes: Poor pavement condition north of ramp merge.

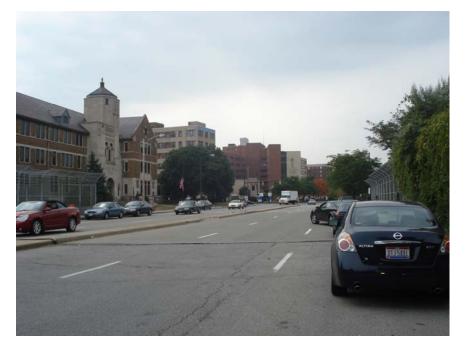
Notes: Parking present during peak hours.

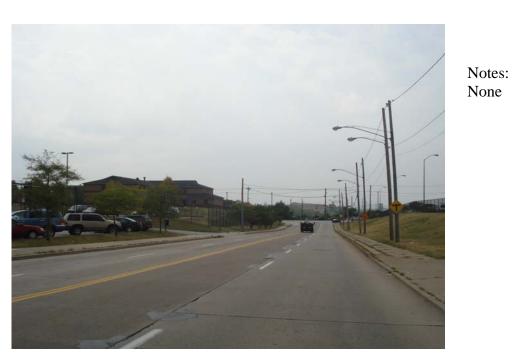
2

East 30th Looking South towards Broadway

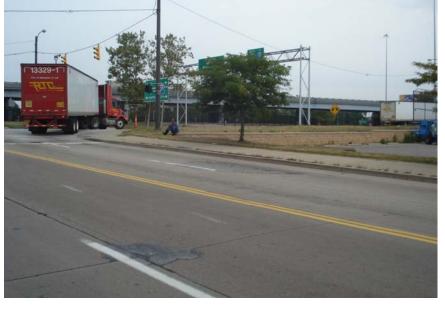
3

East 30th @ Orange Looking North

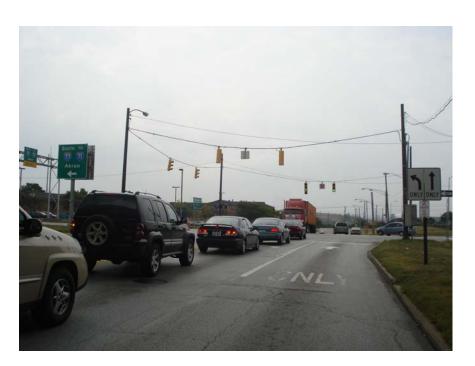
East 30th @ Orange Looking South

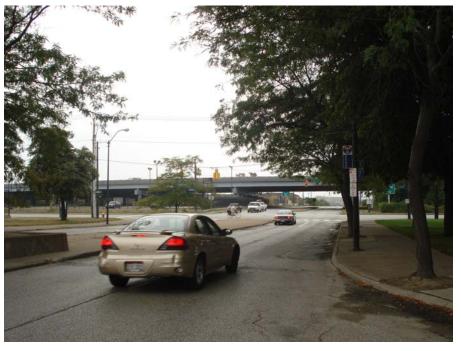
7

Notes: Pavement is in poor condition.

East 30th Looking South towards Woodland

Resurface the southbound approach of East 30<sup>th</sup> north of the intersection as the pavement is in poor condition.

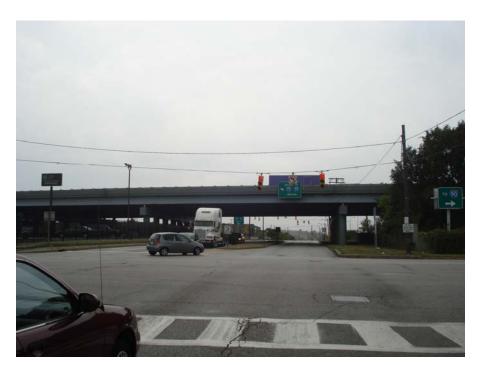
6

East 30th @ Woodland Looking South

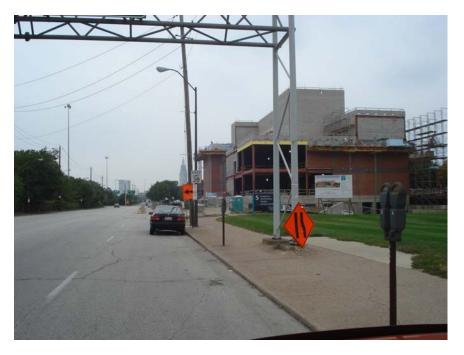
Pavement is in poor condition.

Woodland east of Orange Spur Looking West

Woodland from East 22<sup>nd</sup> to the Orange Avenue spur Resurface the roadway as the pavement is in fair to poor condition.

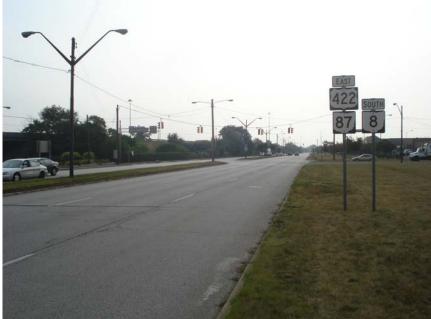
Orange @ East 14th

Looking East

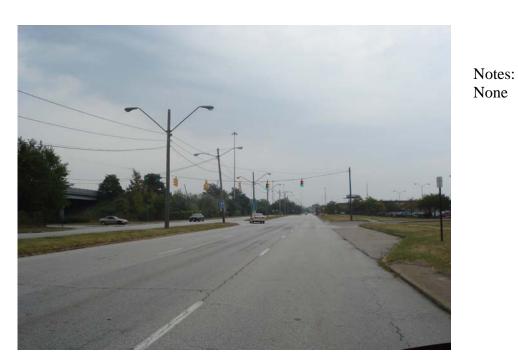
Orange @ East 22nd Looking East

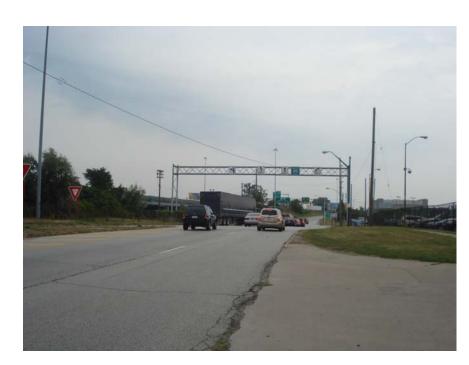
Orange @ IR-77 SB Exit Ramp Merge Looking East

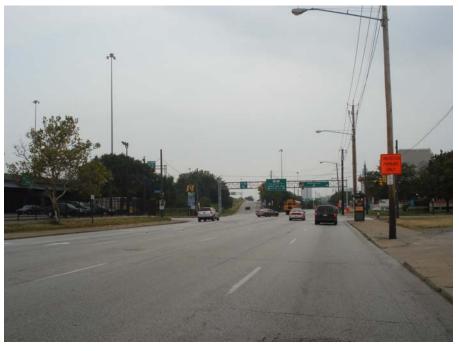
5

Orange @ East 30th Looking East
